**Potomac Horse Center
North Potomac, Maryland
Facility Condition Assessment Report**

November 22, 2023

Reference: **Potomac Horse Center**
Facilities Condition Assessment – Final Report
North Potomac, Maryland

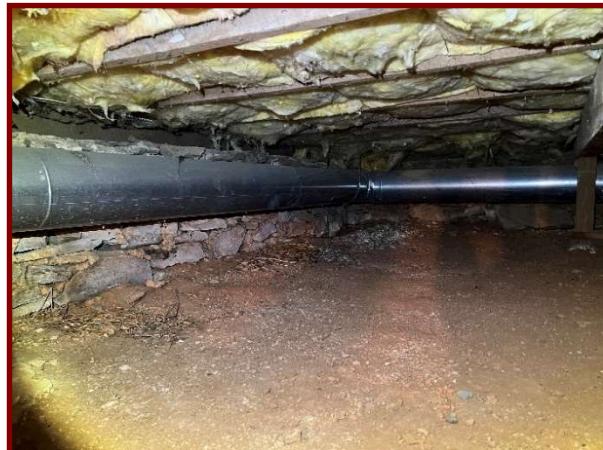
S 1.3 Observation: Mortar for stone foundation walls is significantly degraded at many locations in both basements. It is likely and not unexpected that the soft mortar has weathered away over time since the building was constructed.

S 1.3 – Basement 2 framing and stone masonry foundation wall.

Recommendations: Repoint the foundation walls where mortar has degraded utilizing a pointing mortar that is compatible with the historic nature of the stone wall construction. If during this process walls are noticed to have moved significantly out of plumb, consider selectively rebuilding these sections.

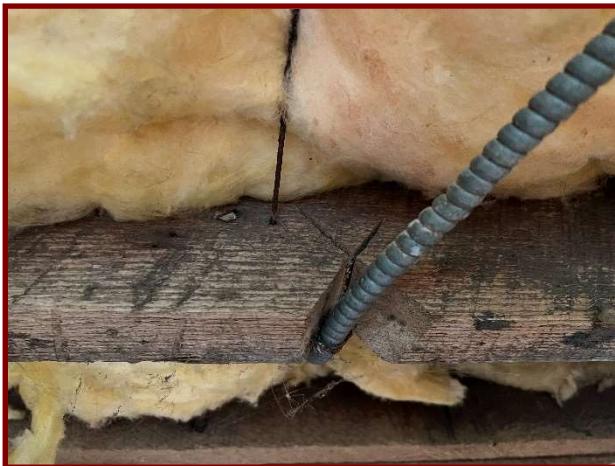
S 1.4 – Notch cut in Basement 2 joists for run of electrical conduit.

Recommendations: Remove and relocate existing conduit. Provide new full-length pressure-treated joist sisters to reinforce notched joists around the locations of the notches.

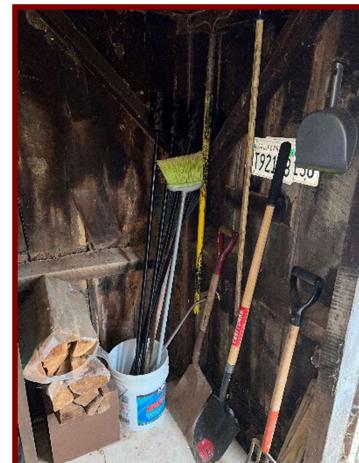
S 1.6 Observation: Due to the degradation of the Smokehouse slab on grade many structural members and the adjoining walls have undergone significant lateral movement, many of which now rest directly on soil. Most of the vertical columns and braces have severe termite and water damage. Daylight is clearly visible through many sections of the structure.

S 1.6 – Northeast corner of Smokehouse. Note column and adjoining walls have shifted significantly.

Recommendations: The structure is currently unstable. We recommend immediate action to avoid unintended collapse of the building. If the structure is historic and warrants retention, then we recommend immediate installation of temporary shoring to support the roof and walls to allow for the replacement of severely damaged framing members. Assume all posts and braces need to be replaced for pricing. Alternatively, if the building is not historically significant, we recommend demolishing and replacing with a stable shed structure.

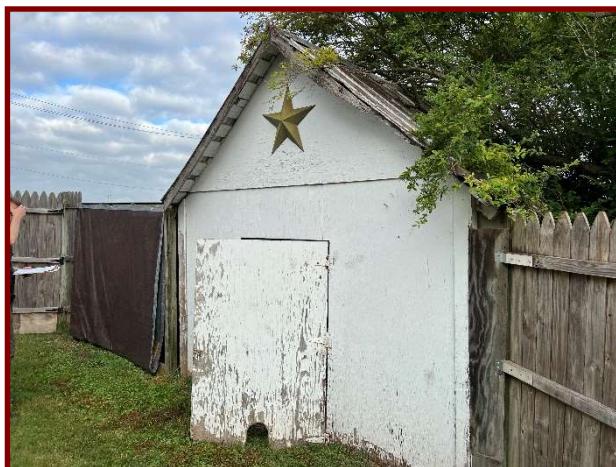
Smokehouse exterior. Siding and paint is deteriorated.

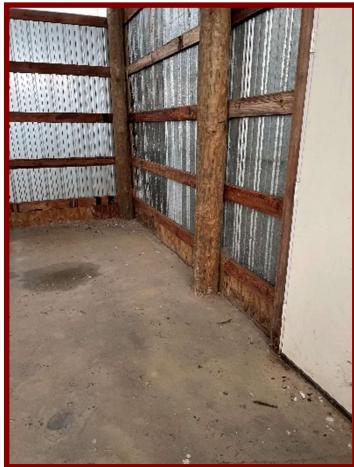
S 2.1a – Posts cast into concrete at northeast side of structure. Note staining at pole bottoms and plywood siding at grade.

Recommendation: At areas with limited to no section loss, clean the sheathing down to bare metal and apply a rust-inhibitive coating compatible with the base metal. Where sheathing has completely weathered away, replace the sheathing in-kind.

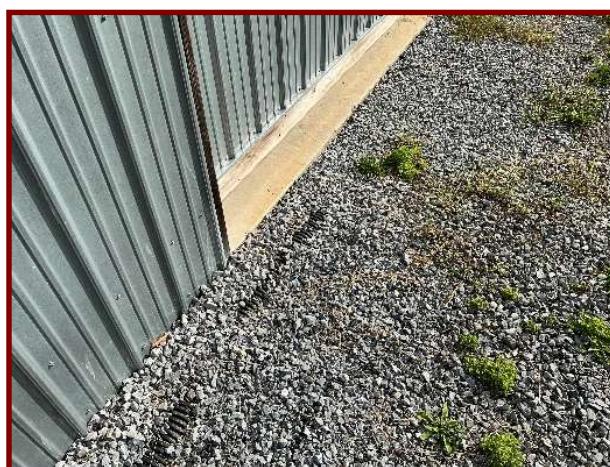
S 2.1b – Exterior at grade. Siding appears in good condition, but lack of waterproofing at grade may lead to future distress.

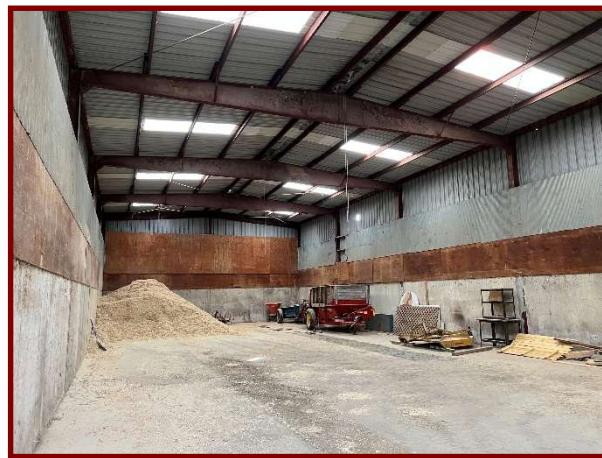
S 3.3a – Interior view of Workshop, looking east.

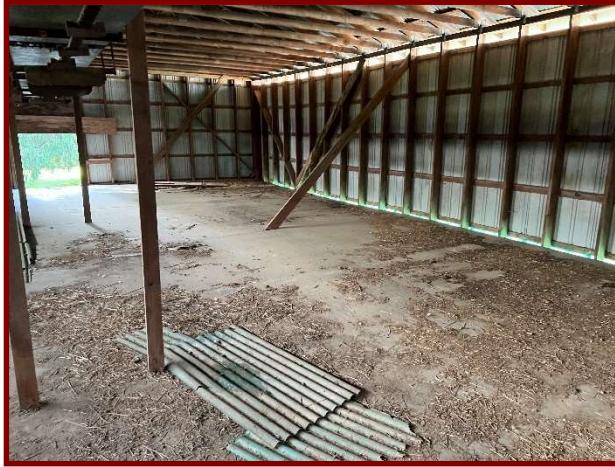
S 4.1 – Top Barn loft wall and roof framing. Note hurricane ties installed between trusses and spandrel beams.

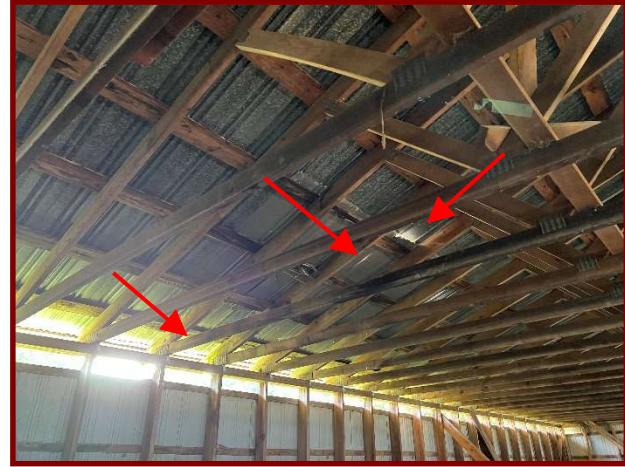
S 4.2 – Top Barn roof framing and decking. Note locations in roof where decking has come loose and sunlight is visible.

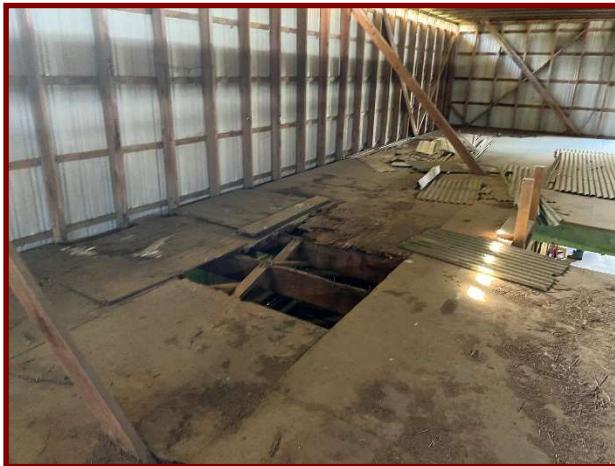
S 4.3 – Collapsed decking at top barn loft.

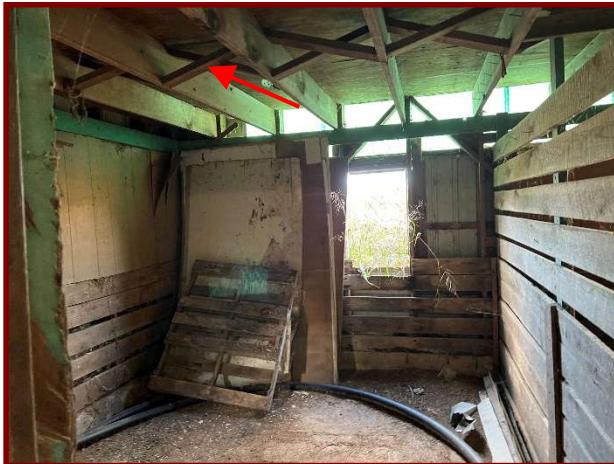
Typical framing at stall. Note joists are braced at their tops and bottoms. A similar condition exists in other stalls.

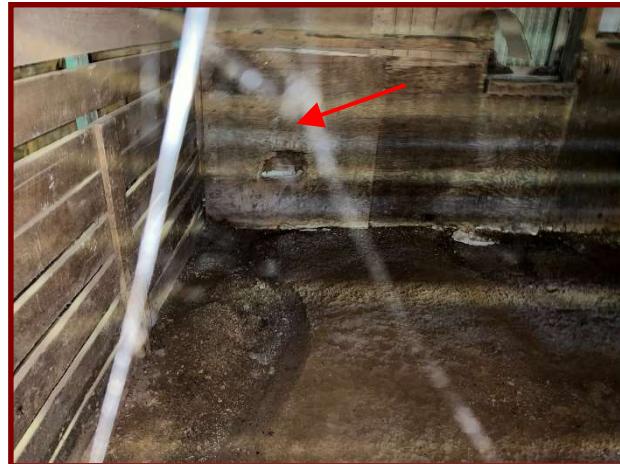
Interior of stall. Note condition of plywood at and above grade. Typical condition.

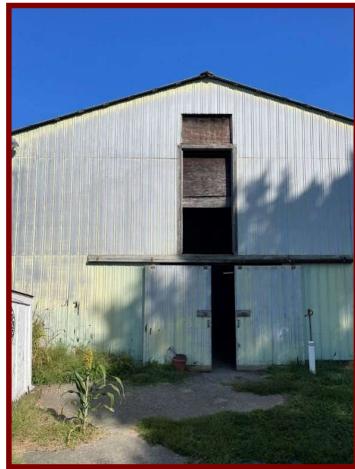
G 4.1a – Barn siding.

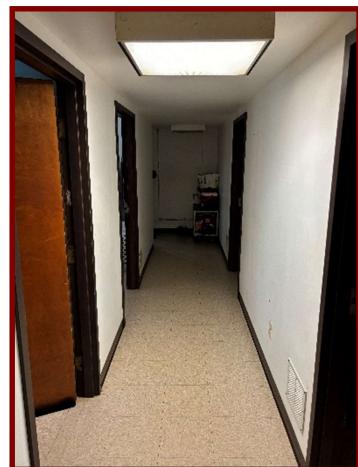
L 5.10 – Unsprinklered Corridor

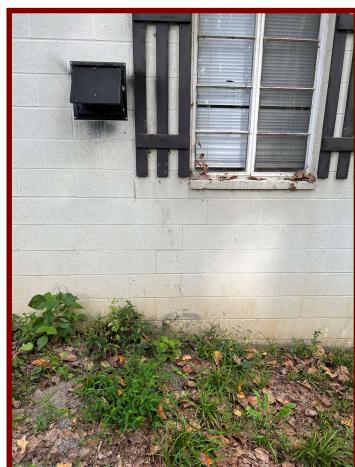
S 5.4 – Step cracks in CMU at south side of building.

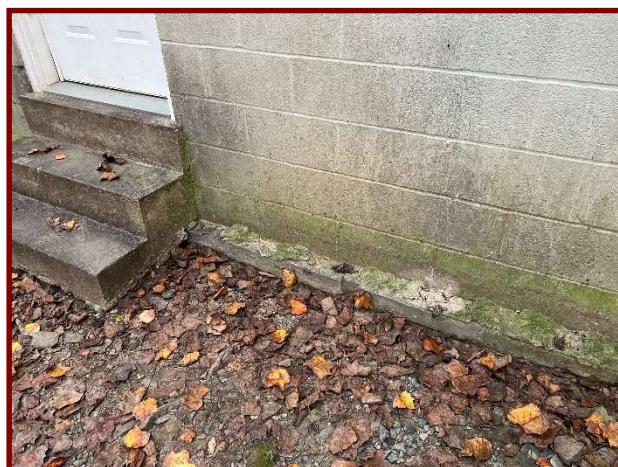
S 5.5 – Exposed footing at northeast side of building.

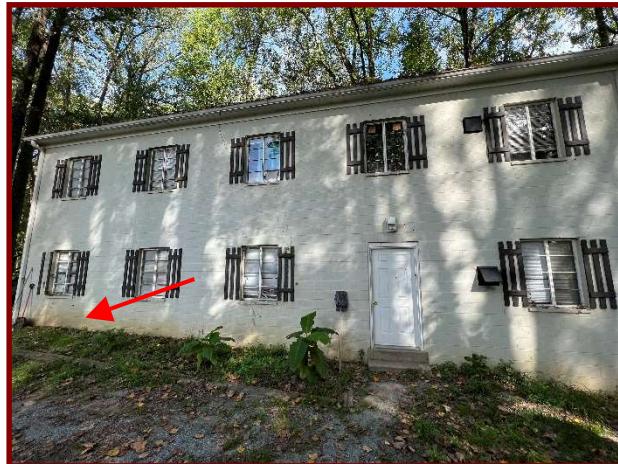
Dormitory Two south elevation.
Note discoloration of brick at base of wall.

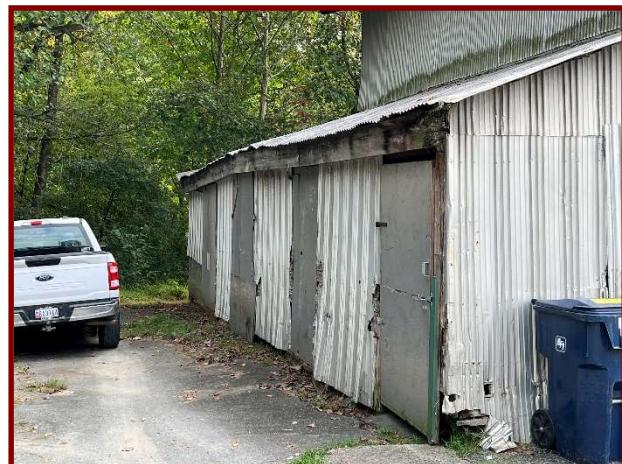
S 6.1b – Deteriorated corrugated metal siding on north side of building.

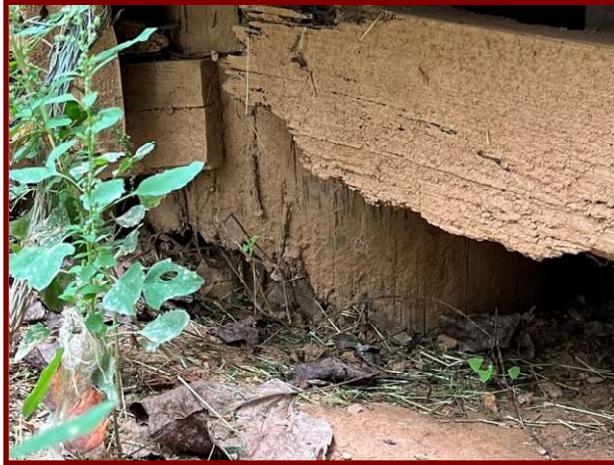
S 6.2a – Heavily degraded lumber at building exterior near grade.

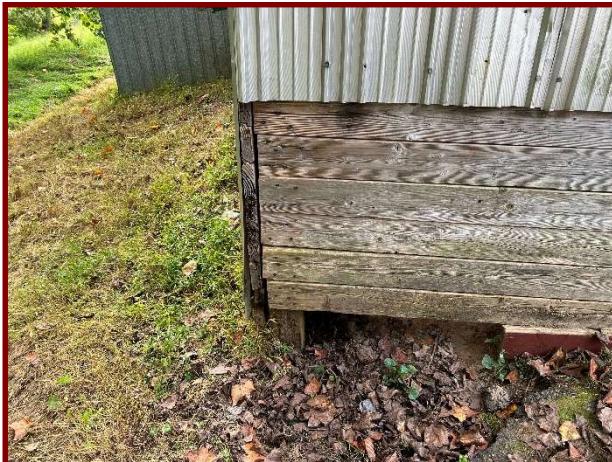
S 6.2c – Condition of exposed lumber at exterior near grade.

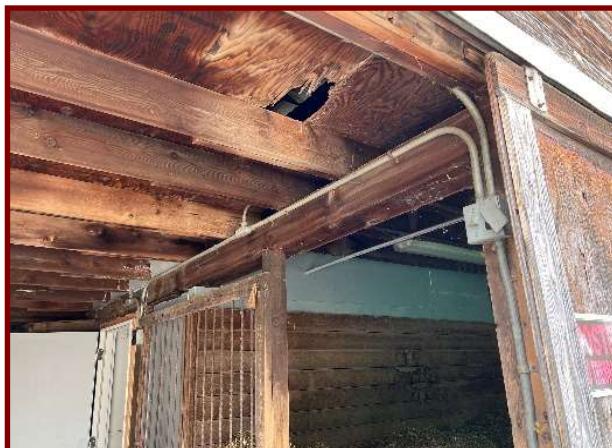
S 6.4 – Interior framing and wooden deck above ground level.
Note rotted deck where shown.

Recommendation: We recommend investigating the roof framing to confirm existing conditions. This investigation may require temporary shoring to provide safe access to loft space.

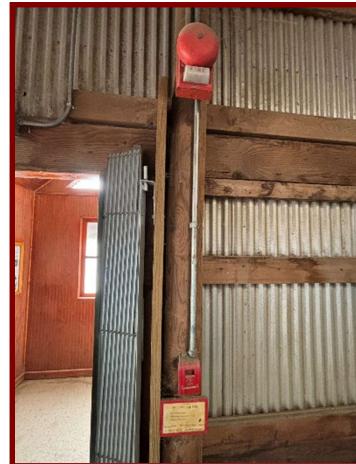
L 7.6a – Fire Alarm Devices

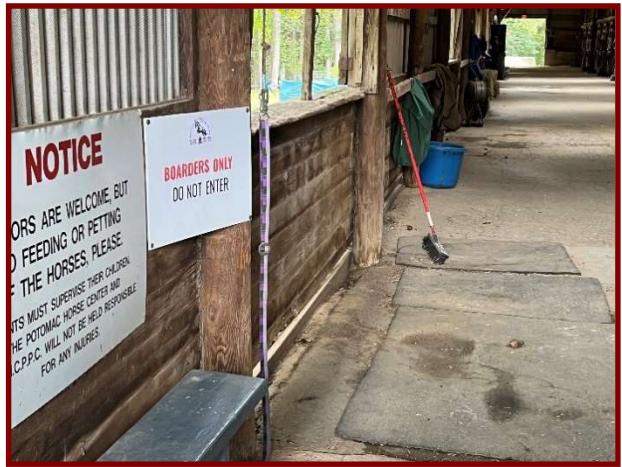
S 7.3a – Typical exterior post condition.

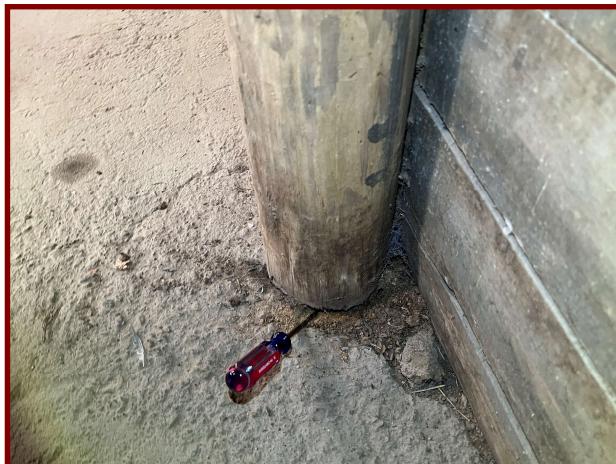
S 7.3b – Post base. Significant deterioration at grade.

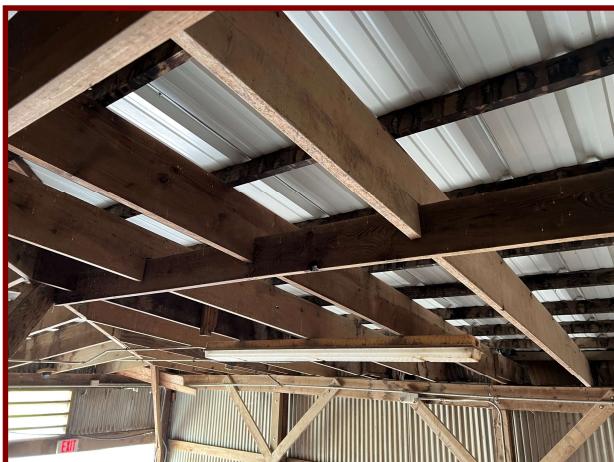
S 7.6a – View of multiple notched beams.

Recommendation: Engage an engineer to analyze the structure and determine the demand on and capacity of the notched rafters. Sister notched rafters as required.

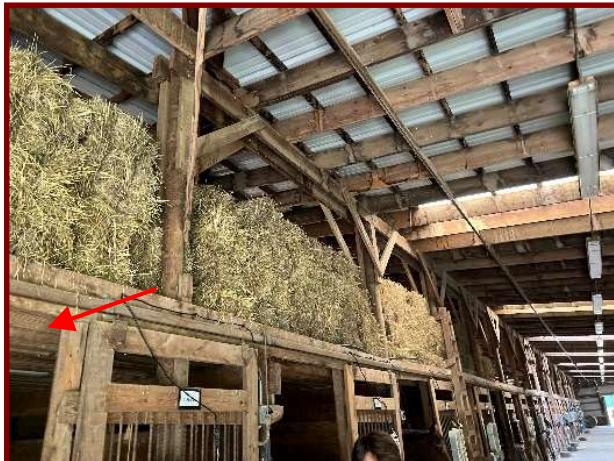
View of hay loft at south side of building. Note closely spaced framing below the loft.

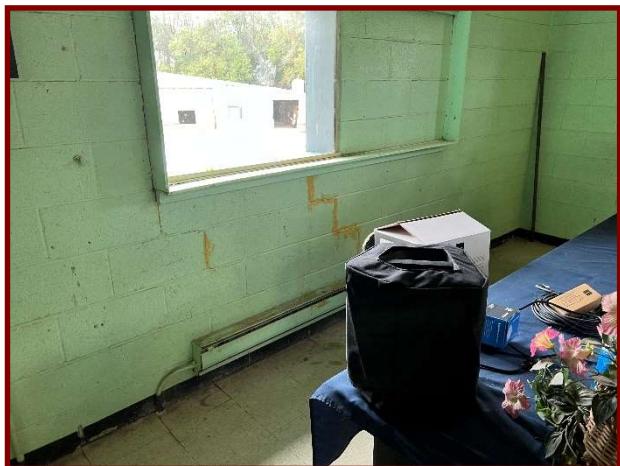
S 8.4 **Observation:** CMU walls in the east addition are cracked in multiple locations in both the interior and exterior. Cracking may be caused by building settlement or other subsurface action.
Recommendation: Investigate the foundations and subsurface conditions around the east addition. Provide adequate drainage in the area surrounding the addition to mitigate potential soil consolidation. Repair cracks in CMU walls to prevent further deterioration of these areas. Install crack monitors to determine if movement is continuing or has stopped.

S 8.4b – Cracked CMU in east addition.

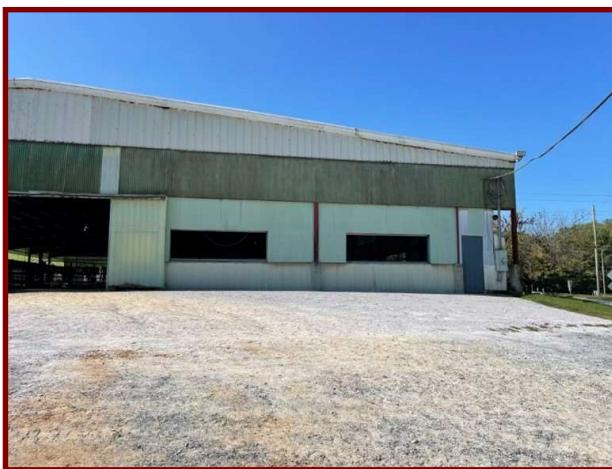
G 8.1a – Deteriorating exterior façade.

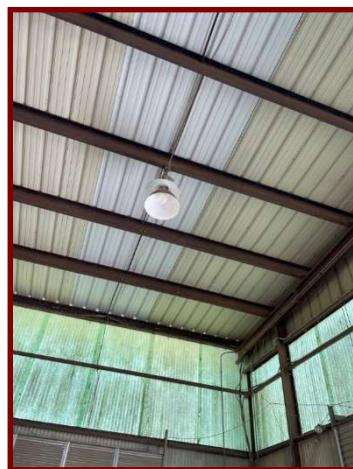
G 8.1b – Translucent panels.

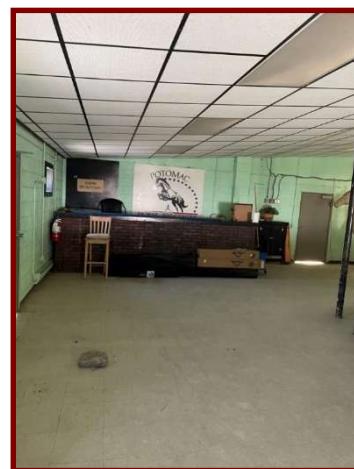
S 8.3 – Paint and install conduit for surface mounted wiring.

Recommendation: Install conduit for electrical wires to surface-mounted fixtures.

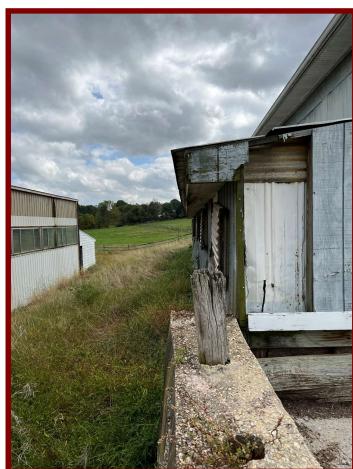
S 9.2a – North side of Gray Barn. Deteriorating concrete wall.

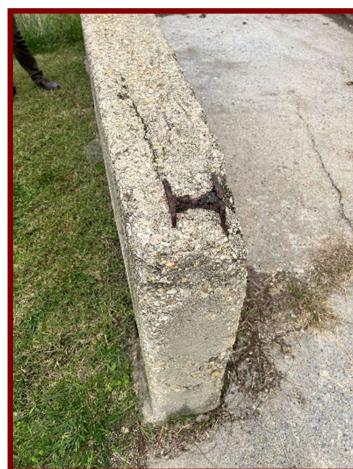
S 9.2b – Exposed steel in north concrete wall.

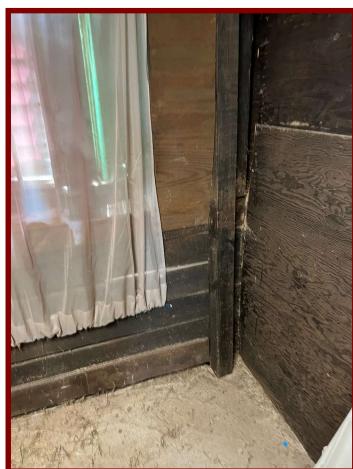
S 9.3a – Deteriorated siding and post in Gray Barn stall.

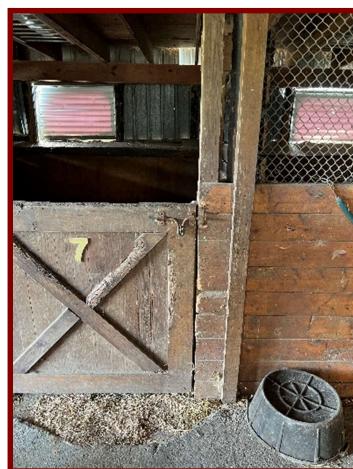
S 9.3b – Deteriorated lumber near stall entrance.

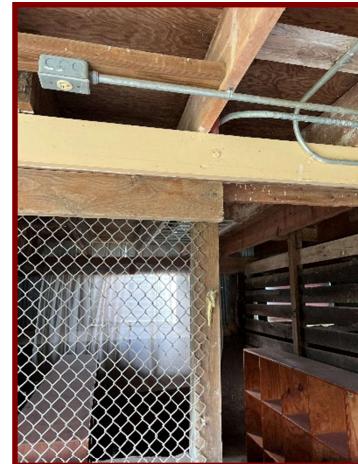
S 9.4 **Observation:** Many joists and headers at the lower level have been sistered with new lumber, and many posts have either been added or cut over the building's service life. It is clear from these observations that the load path has changed significantly over time and is at this point effectively indeterminate.
Recommendation: Inspect and analyze the building further to determine the load path. Once this is done, modify and reinforce the structure as necessary to ensure the facility is up to current code standards.

S 9.4b – Multiple beams that appear to have been constructed at different times bear at the same location.

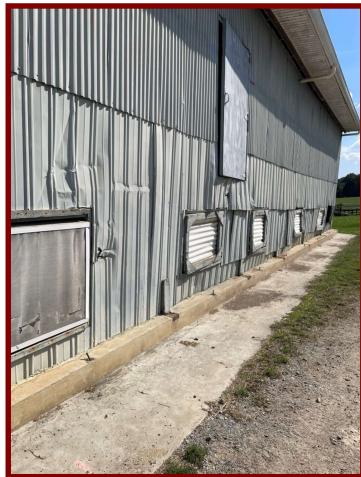
G 9.1a – Damaged siding.

Recommendation: Replace damaged siding, trim, and doors.

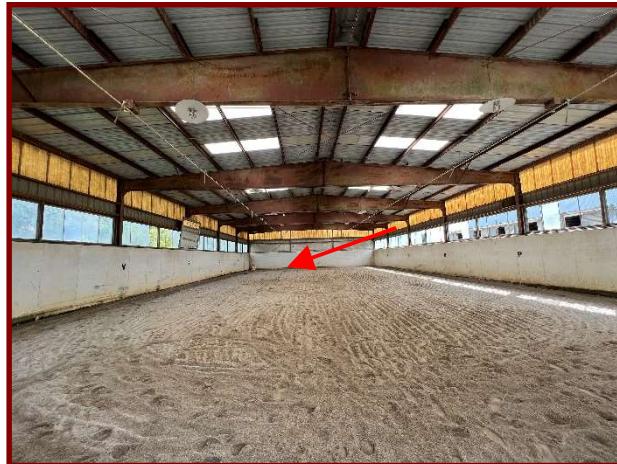
S 10.2 – Interior view of Small Arena. Note damaged column second from left.

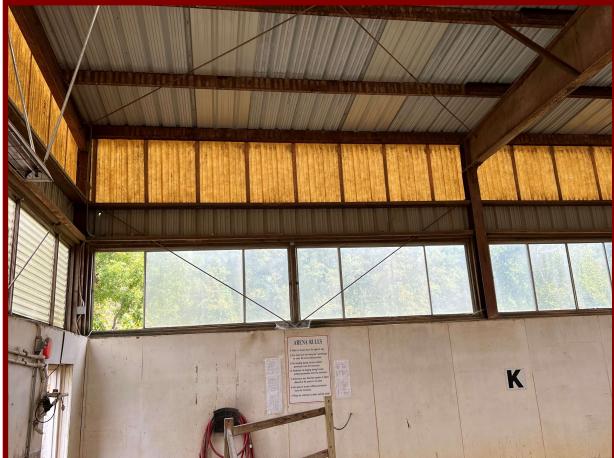
S 10.4a – Condition of framing. Vicinity of column "K".

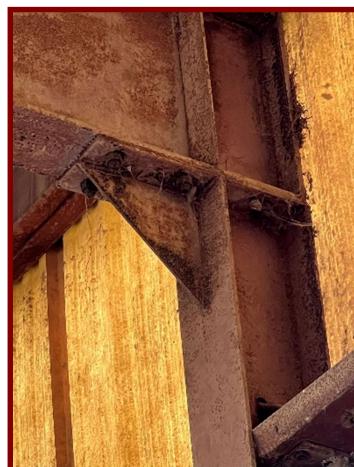
S 10.5b – Alternate view of buckled bearing plate stiffener.

Recommendation: Engage an engineer to analyze the structure and confirm the stiffeners as designed are sufficient to support the load from the girder. If connection is not adequate, repair structure as required. If connection is adequate, repair the buckled bearing plate.

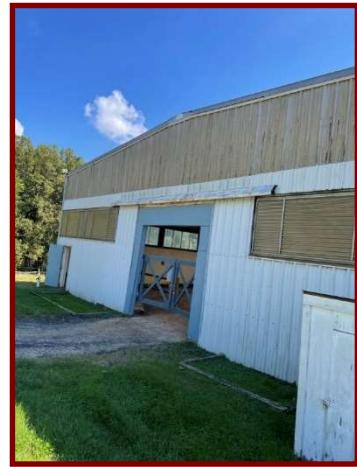
G 10.1b – Exterior finish deteriorating.

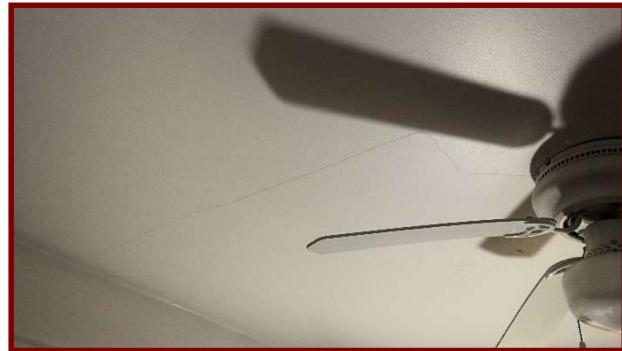
G 11.3a – Drywall Cracking

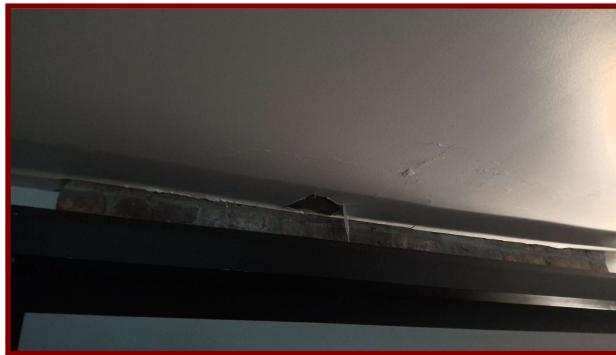
G 11.3b – Drywall Damage

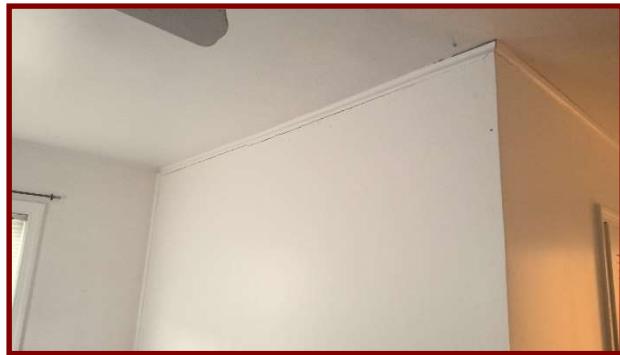
G 11.3c – Drywall Cracking
