**Potomac Horse Center
North Potomac, Maryland
Facility Condition Assessment Report**

November 22, 2023

Reference: **Potomac Horse Center**
Facilities Condition Assessment – Final Report
North Potomac, Maryland

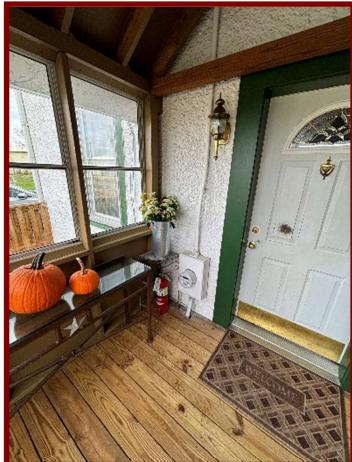
L 1.1 – Fire Extinguisher Location

Recommendations: Fire extinguisher should be located within the building, in a conspicuous location so that is readily available for occupant use. This is so that occupants do not re-enter the building to fight the fire after having exited.

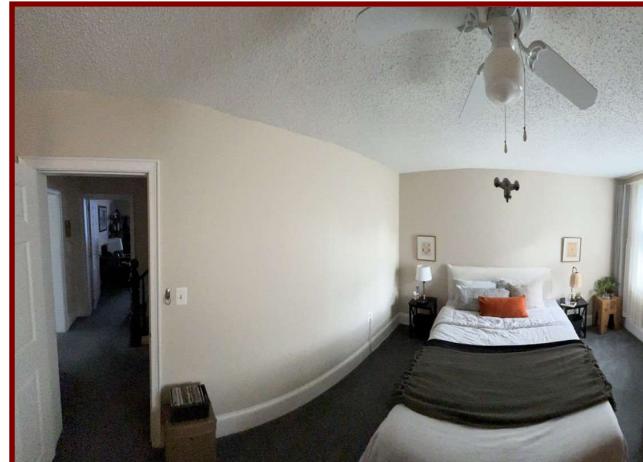
L 1.2 – First Floor Sleeping Room (No Smoke Alarm)

Recommendation: Provide Smoke alarms in the sleeping room and outside of the sleeping room in the immediate vicinity of the sleeping room, on the first floor (NFPA 101, 24.3.4.1.1).

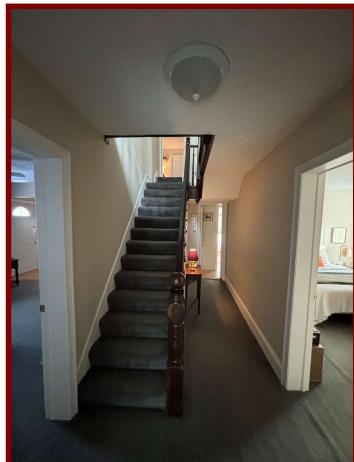
L 1.3 – First Floor Stairwell (No CO Alarms)

Recommendation: Provide combination Smoke/CO alarm at the base of the stairs, outside of the first floor sleeping room in the immediate vicinity of the sleeping room (NFPA 101, 4.3.4.2.2).

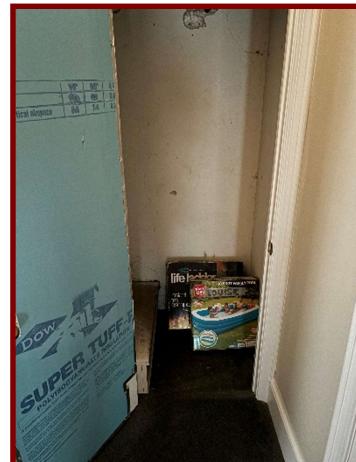
L 1.4 – Storage in Attic Stairs

Recommendation: Move storage out of stairs to attic in order to keep egress from attic clear.

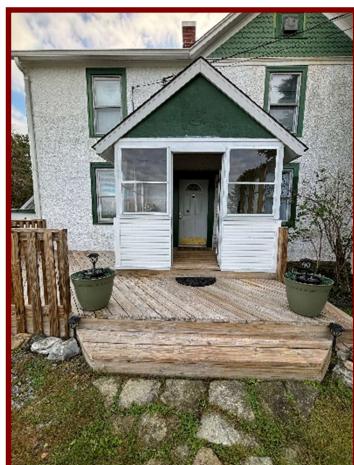
L 1.5 – Exterior Stairs

Recommendation: Provide minimum of one handrail for stairs at front of building (NFPA 101, 7.2.2.4.1.6)

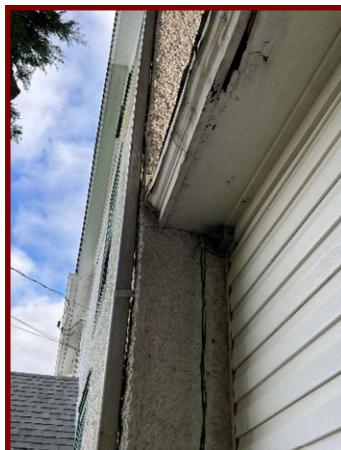
S 1.1 Observation: There are a number of small cracks in the exterior finish, which consists of wood sheathing, a membrane, wire mesh, and a cementitious pebble mesh coating. If left untreated these cracks provide a route for water entry into the wall assembly, which will result in additional cracking and damage as water freezes and thaws. Painted lumber, such as the underside of eaves, is also chipped and peeling in some locations, exposing the wooden substrate to the elements.

S 1.1 – Chipped and peeling paint at underside of closed eave.

Recommendations: Repair and seal cracks. Repaint areas where paint is significantly weathered. Refer to architectural recommendations for additional information.

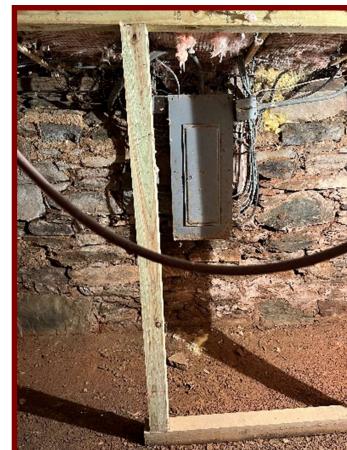
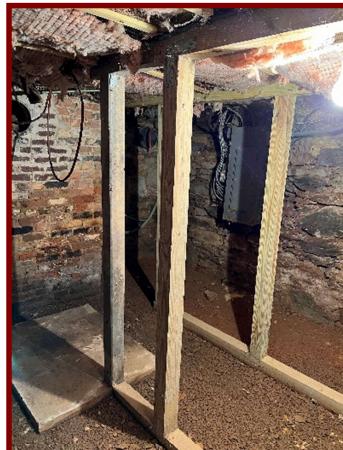
S 1.2 Observation: In Basement 1, 4x4 wood shoring posts and wood sills have been installed to support termite-damaged original first floor joists. These sills rest directly on the gravel floor of the basement space. Per the tenant, termite inspection and insecticide spraying takes place every June, and there has been no known new activity in quite some time. However, the sills are discolored, indicating exposure to moisture. Other vulnerable elements in this space, such as the metal electrical box, are also corroded. If no action is taken the ambient humidity will continue to degrade the wooden sills and posts, eventually leading to a loss of structural capacity.

S 1.2a – Basement 1 wall. Note corrosion on electrical box.

S 1.2b – Shoring in Basement 1. Note signs of moisture present at bottom of sills on gravel grade.

Recommendations: Investigate condition of existing floor framing to determine if current extent of shoring is sufficient. If shoring is desired, then take following measures to protect shoring from moisture damage:

- Paint shoring posts and headers to provide protection against moisture exposure.
- To permanently remediate the situation, elevate new pressure treated (PT) sills from gravel floor with concrete curbs or masonry foundations to prevent moisture wicking from grade. Confirm the new sills (PT) and posts are sufficiently sized to meet code requirements.
 - o Alternatively, sister the termite-damaged wood joists with new, pressure-treated lumber or replace existing floor framing with new PT framing.

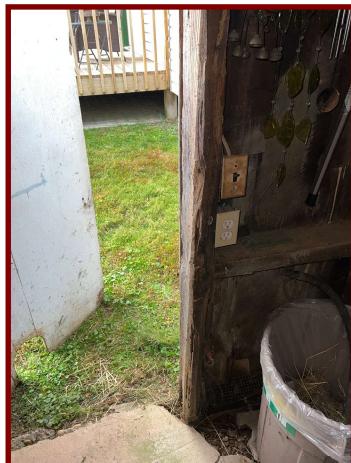
S 1.5 Observation: The Smokehouse slab on grade is heavily cracked and is completely degraded below many perimeter bearing wall wood sill plates.

S 1.5 – Smokehouse wall near entrance. Note slab on grade has deteriorated and wall is unsupported. Common condition.

Recommendations: The existing slab is not suitable for continued use. We recommend replacing the slab as part of a full smokehouse repair or replacement project. Coordinate slab on grade requirements with the needs of the shed repairs or replacement as outlined in the following section below.

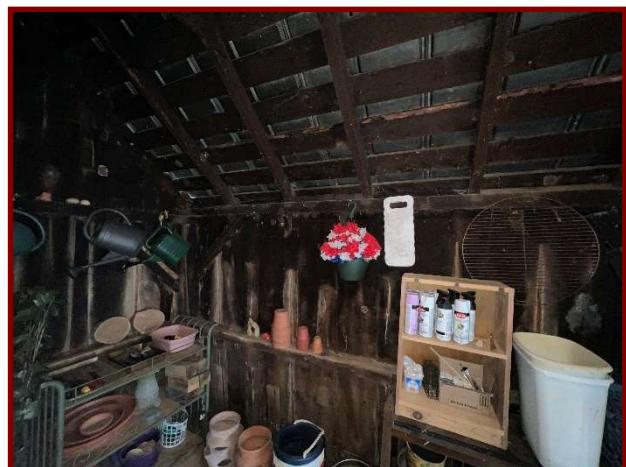
S 1.6 Observation: Due to the degradation of the Smokehouse slab on grade many structural members and the adjoining walls have undergone significant lateral movement, many of which now rest directly on soil. Most of the vertical columns and braces have severe termite and water damage. Daylight is clearly visible through many sections of the structure.

Smokehouse interior.

Recommendations: The structure is currently unstable. We recommend immediate action to avoid unintended collapse of the building. If the structure is historic and warrants retention, then we recommend immediate installation of temporary shoring to support the roof and walls to allow for the replacement of severely damaged framing members. Assume all posts and braces need to be replaced for pricing. Alternatively, if the building is not historically significant, we recommend demolishing and replacing with a stable shed structure.

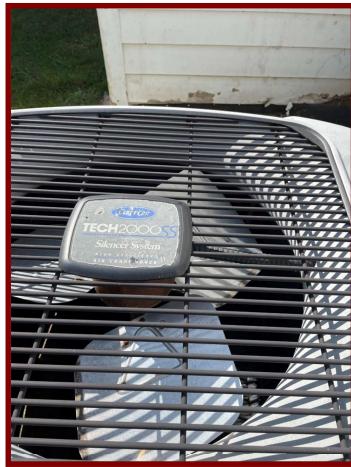
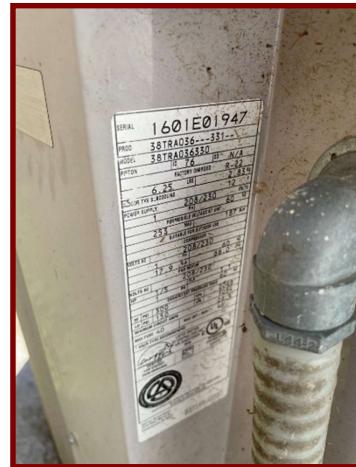
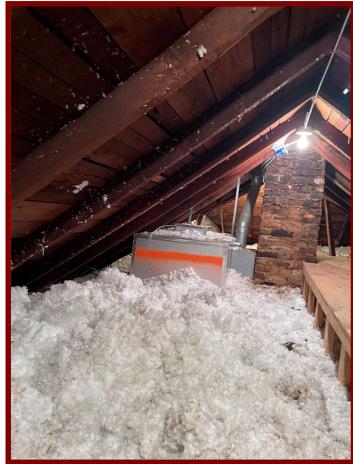
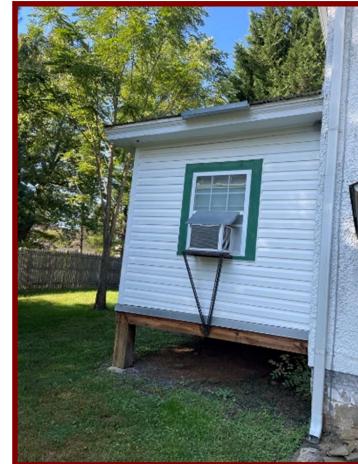
G 1.1 **Observation:** The air conditioning system compressor was manufactured by Carrier and indicated as having been manufactured in April of 2001 (22 years old), indicating it is beyond its normal useful life of 15-20 years. The date of manufacture of the window air conditioner could not be determined.

G 1.1a – Exterior Unit.

G 1.1b – Air Conditioning System

G 1.1c – AHU in attic.

G 1.1d – Window Unit.

Recommendation: Replace the air conditioning systems. Due to the phase out of R410a refrigerant, the entire system should be replaced.

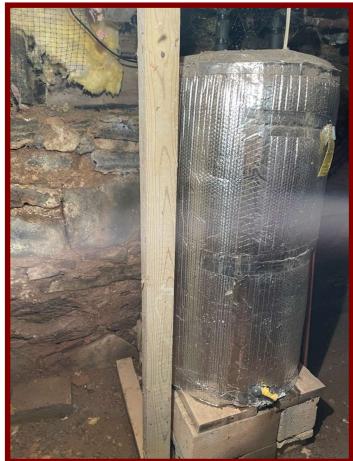
G 1.2 – Water heater.

Recommendation: Replace the water heater.

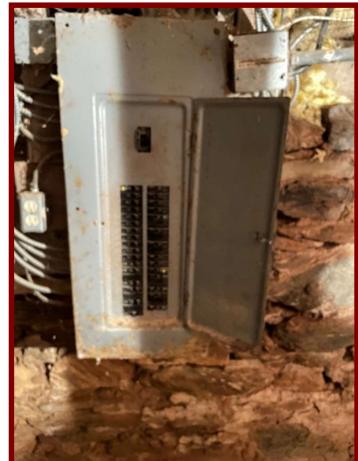
G 1.3 **Observation:** The electric service panel was located in Basement 1. Due to the high humidity levels the panel was showing signs of deterioration.

G 1.3 – Electric Service Panel.

Recommendation: Replace the electrical panel.

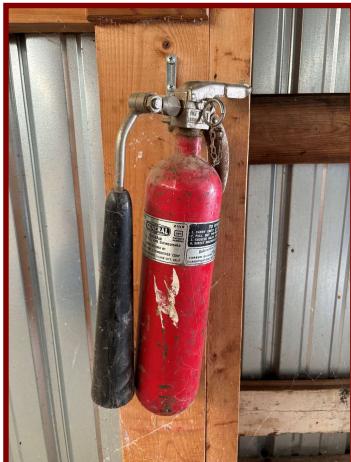
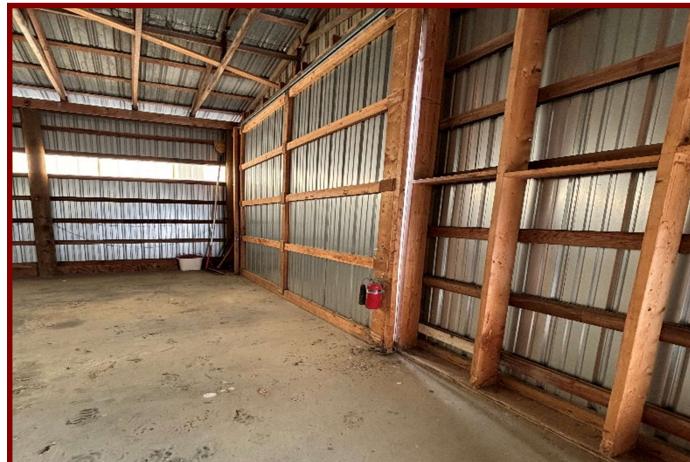
L 2.1a – Fire Extinguisher

L 2.1b – Fire Extinguisher Location

Recommendations: Provide a new fire extinguisher in a conspicuous location that is readily accessible. Locate the fire extinguisher on a fixed surface.

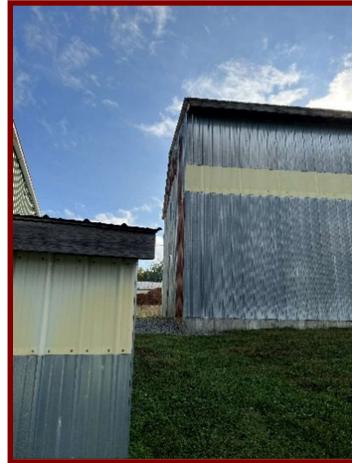
S 2.2 – Exterior view at northwest side.
Note corroded siding at north end of building.

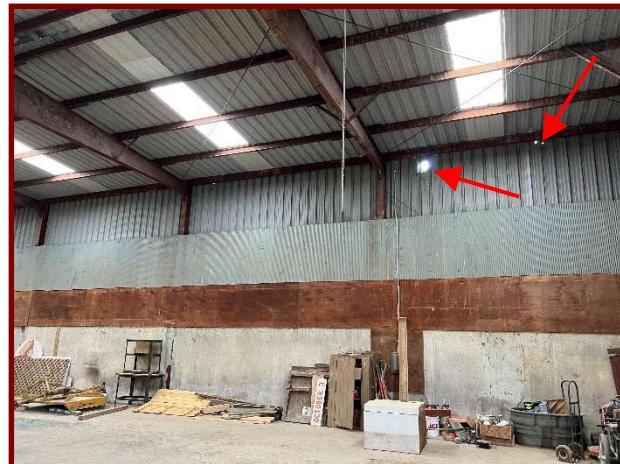
S 3.1b – Interior view of Workshop, looking south. Note holes in wall panels.

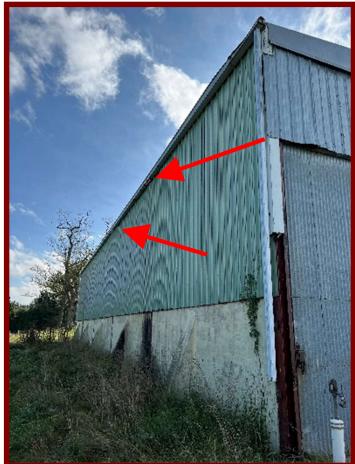
S 3.2 – Exterior view of Workshop north elevation.
Note corroded gutters where indicated.

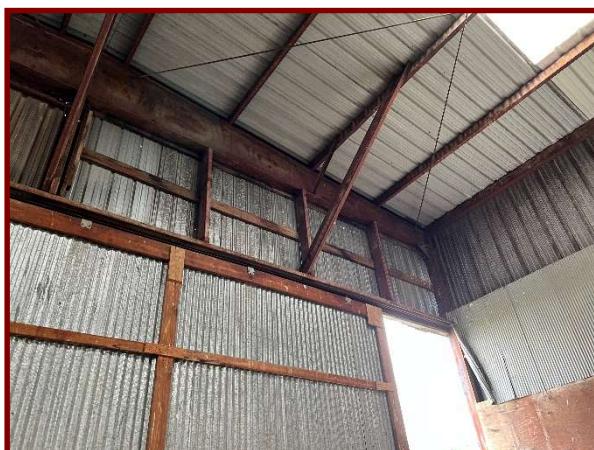
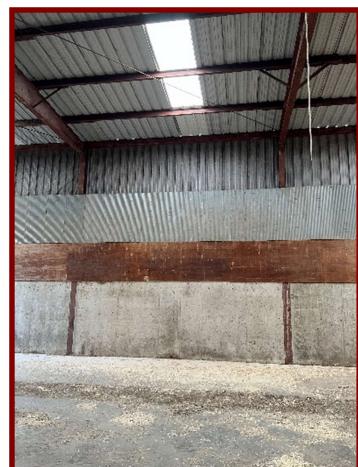
S 3.3 **Observation:** We observed minor surface rust at many locations, likely due to the structure's general exposure to atmospheric moisture and expected decay of surface primer over its service life.

S 3.3b – Interior view of Workshop, looking west.

S 3.3c – Interior view of Workshop, looking north.

Recommendation: Grind rusted steel until bare metal is exposed and apply a rust-inhibitive coating. If during this process members are discovered to be significantly corroded, take corrective action such as repairing, reinforcing, or replacing the members in question.

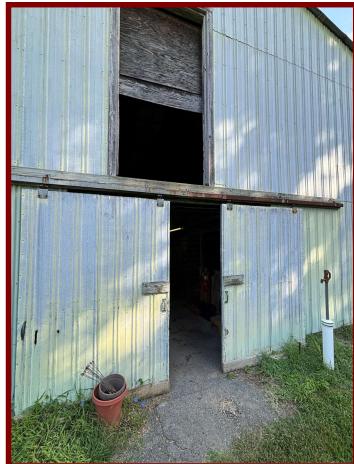
L 4.1 – Vegetaion growing on Sides of Sliding Doors

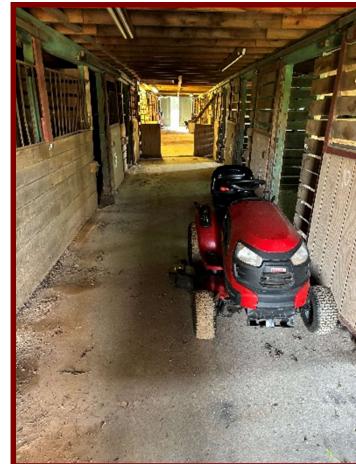
L 4.2 – Storage Within Egress Path

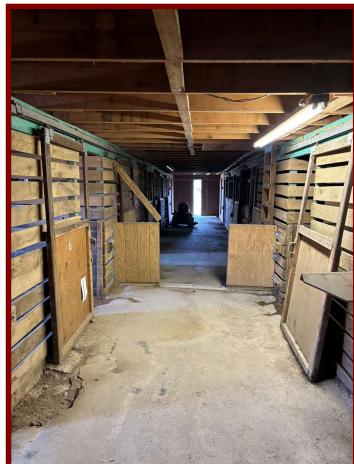
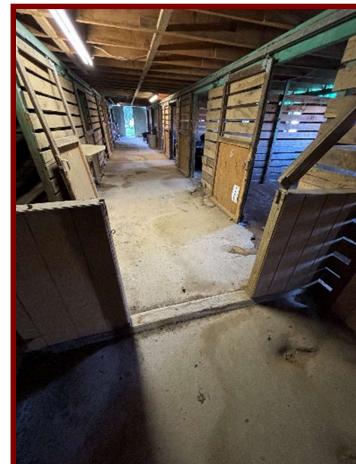
L 4.3a – Uneven Walking Surface

L 4.3b – Uneven Walking Surface

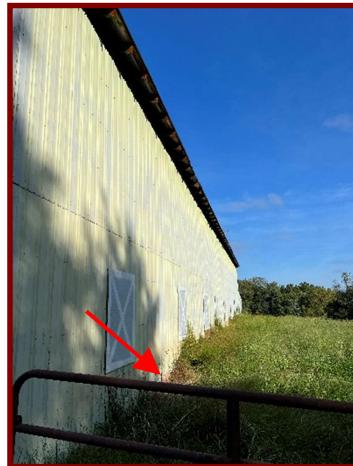
S 4.4 – Exterior view of Top Barn east elevation.
Note condition of siding at grade.

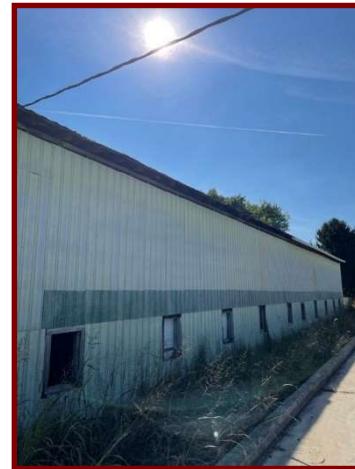
G 4.1 **Observation:** The barn siding finish was observed to be damaged and deteriorated.

G 4.1b – Barn siding.

Recommendation: Repair and repaint the barn siding.

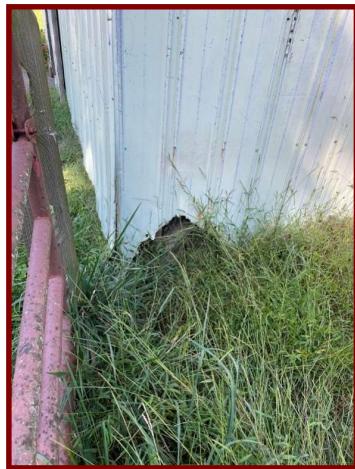
G 4.1c – Barn siding.

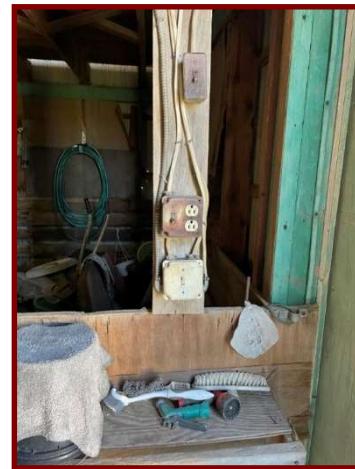
G 4.2 **Observation:** The electrical outlets were observed to be significantly deteriorated.

G 4.2 – Electrical outlets and switches.

Recommendation: Replace outlets and switches as necessary.

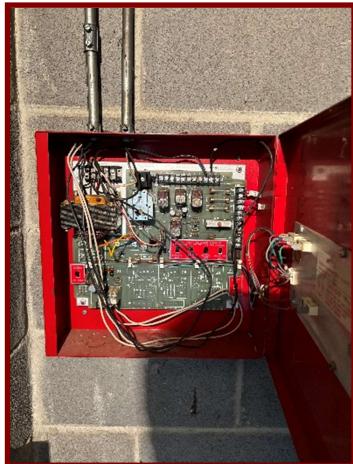
L 5.1 **Observation:** The fire alarm transformer appears corroded, possibly beyond useful life, and may not be currently functional. There were no tags present to indicate the date of the last fire alarm test or maintenance.

L 5.1 – Fire Alarm Control Unit

Recommendations: The existing fire alarm system should be replaced with a new fire alarm system. The new Fire Alarm Control Unit (FACU) should be located within a NEMA 4x (weatherproof) enclosure due to the ambient conditions of the utility room where the existing FACU is located. The new fire alarm system should be designed to the applicable requirements of the Lodging or Rooming House chapter of NFPA 101 (NFPA 101, 26.3.4), which requires the following:

- Provide a heat detector within the room containing the FACU (Heat detector used due to ambient conditions of space).
- Provide carbon monoxide detectors outside of each separate sleeping area in the immediate vicinity of the rooms (can be combo smoke/CO alarm).

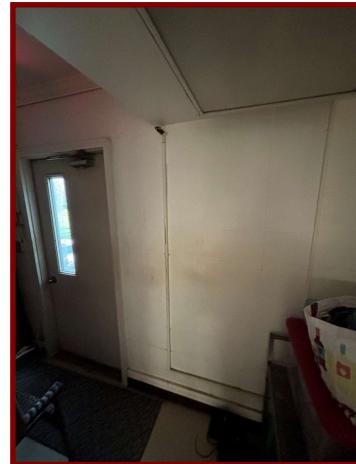
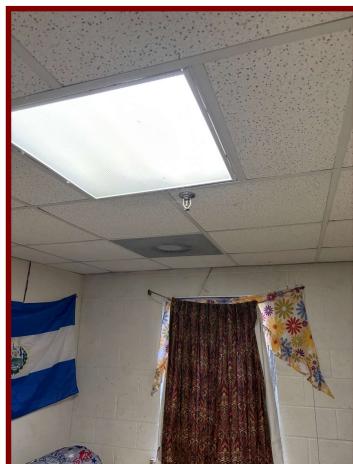
L 5.2a – Sprinkler at End of Hallway

L 5.2b – Sprinkler Within Room

Recommendation: Extend the sprinkler system to include sprinkler protection within the entire hallway on both levels and within each sleeping room. Sprinkler system should comply with the requirements of NFPA 13D, which only omits coverage in bathrooms less than 55 ft² and in closets and pantries that do not exceed 24 ft² and are of a non-combustible material (NFPA 13D, 8.3).

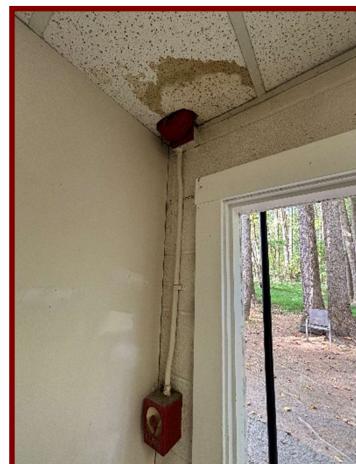
L 5.3 – Fire Alarm Bell Through Ceiling

Recommendation: Provide new notification appliances within Dormitory Two building per comment L 5.1 above.

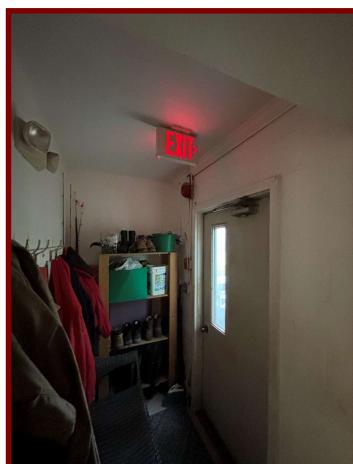
L 5.4 – Storage at Exit Door

Recommendation: Move storage out of exit path to provide egress path that is minimum 28 inches in width (NFPA 101, 7.3.4.1.2) and clear from obstructions and tripping hazards (NFPA 101, 7.1.10.1).

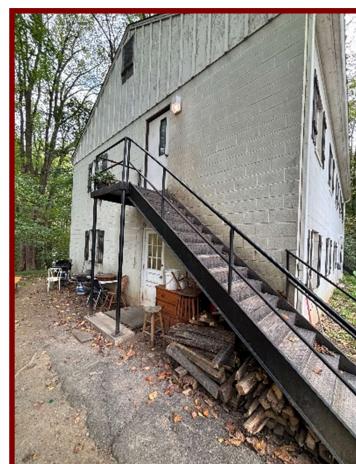
L 5.5 **Observation:** Exterior stairs contain combustible storage underneath.
Recommendations: Remove storage from underneath exterior exit stairs.

L 5.5 – Storage Underneath Exterior Stair

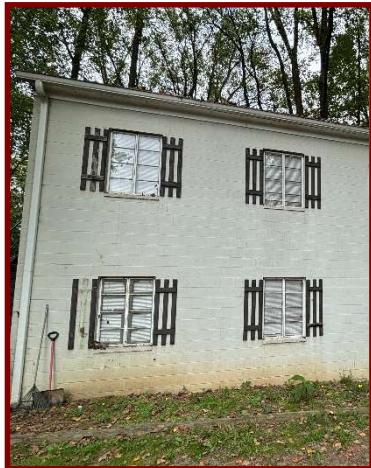
L 5.6 **Observation:** A secondary means of escape is required within the Dormitory Two building. Windows with direct access to the exterior with minimum 5.7 ft² clear opening area, located not more than 20 ft above grade are permissible secondary means of escape (NFPA 101, 26.2.1.2, 24.2.2). Windows used as a secondary means of escape must be operable from the inside without the use of any special tools, keys, or special effort.
Recommendations: Windows do not appear to meet the requirements of a secondary means of egress. Provide new windows that meet the requirements.

L 5.6 – Secondary Means of Escape

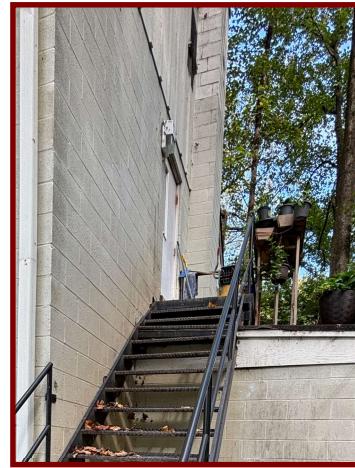
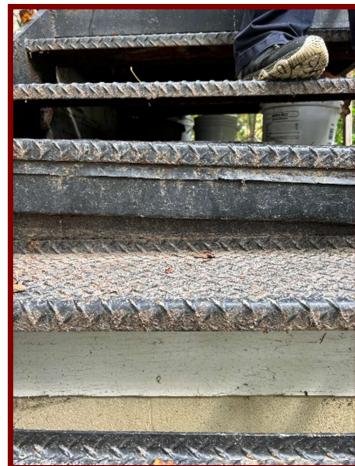
L 5.7 **Observation:** Exterior exit stair has one stair on the roof, at a sloping angle that is greater than the allowed $\frac{1}{4}$ inch per foot (NFPA 101, 7.2.2.3.4).
Recommendations: Provide stair that is level with the ground at a slope of no more than $\frac{1}{4}$ inch per foot (NFPA 101, 7.2.2.3.4)

L 5.7a – Sloped Exterior Stair

L 5.7b – Sloped Exterior Stair

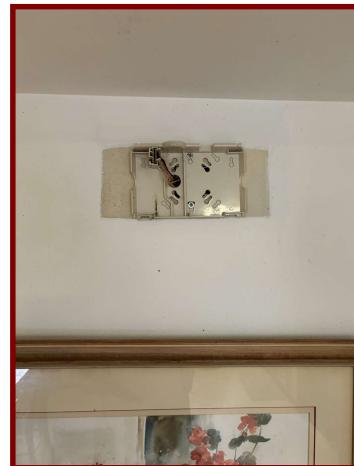
L 5.9 **Observation:** Egress lighting is removed from wall.
Recommendation: Provide new egress lighting in same location as previous.

L 5.9 – Missing Egress Light

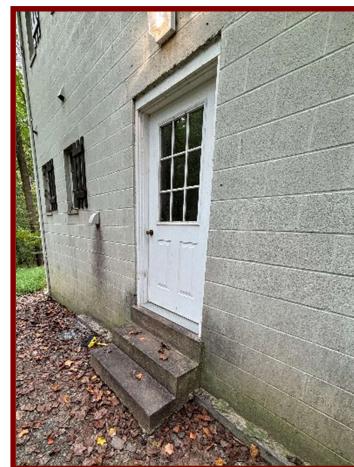
L 5.11 **Observation:** Multiple exits have immediate steps down at the door discharge. In existing buildings, floor level outside of the door opening is permitted to be one step lower than inside, but no more than 8 inches.
Recommendation: Raise floor level at exit discharge so that exit discharge level is no more than 8 inches below floor level inside for a distance equal to the door leaf (Door width, approximately 36 inches) (NFPA 101, 7.2.1.3.5, 7.2.1.3.2). Recommendation is to provide concrete or wood/deck landing outside of each exit at the same level as the inside floor. Where multiple steps are required to reach the ground, provide a handrail.

L 5.11 – Steps at Exit Discharge

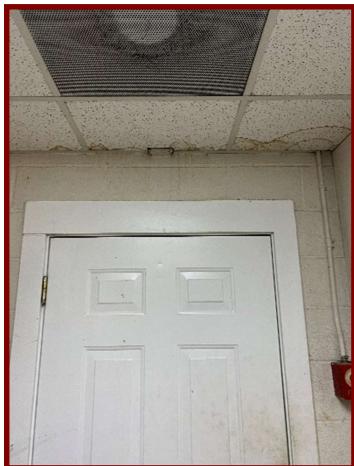
S 5.1 **Observation:** Ceiling tiles near the west entrance of the building are discolored, indicating moisture or water in the ceiling above.
Recommendation: Investigate the building enclosure and MEP equipment within the ceiling space for sources of water damage. Evaluate the base building structure in the vicinity of the water staining for possible damage. If found, take steps to mitigate the offending condition.

S 5.1 – Moisture damage at interior ceiling near west entrance.

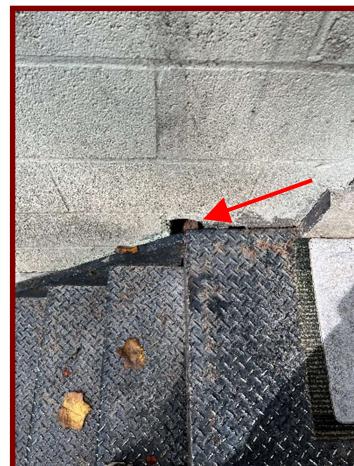
S 5.2 **Observation:** The upper landing of the exterior metal-framed stair present at the east gable end of the building incorporates steel spandrel beam framing, which pockets into the adjacent exterior CMU wall construction. We did not observe supplemental flashing or other means of waterproofing or enclosure protection to prevent moisture from infiltrating into the CMU wall construction at this location. The steel beam element within the pocket also appears rusted.
Recommendation: Patch hole in masonry wall once stair is removed per recommendations in section D.

S 5.2 – Stairs at east side of building. Note bearing pocket in exterior CMU wall.

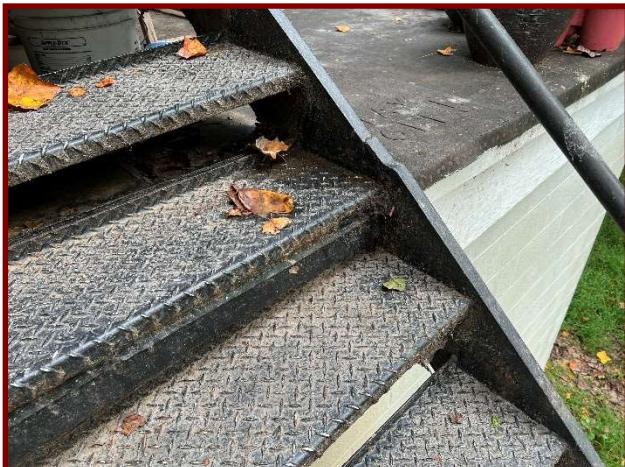
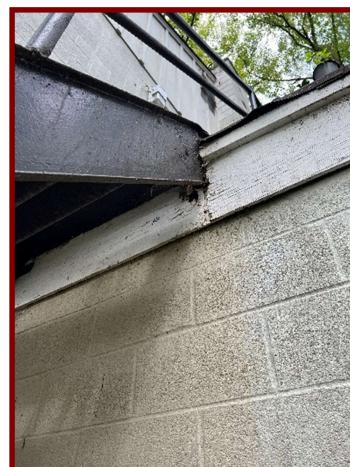
S 5.3 **Observation:** Installation detailing of the exterior metal-framed stair present at the east gable end of the building has resulted in the stair stringers potentially bearing on the exterior wall construction of the mechanical space. We are uncertain if the wall of the mechanical room is suitable to structurally support the vertical load superimposed by the metal-framed stair stringer above.
Recommendation: The stairs appear to not be code compliant, and we recommend replacing the existing stair with new engineered stairs. New stairs should be oriented to avoid interacting with the room structure. This will require new foundations at base of the stairs and new framing at the top of the stairs.

S 5.3a – Stair tread bearing on low roof at east side of building.

S 5.3b – Stair stringer bearing on low roof at east side of building.

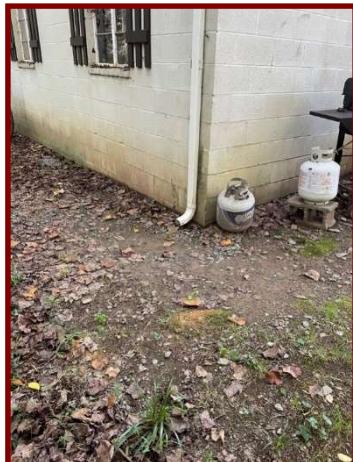
G 5.1 **Observation:** Downspouts from the roof gutters do not extend far enough from the building foundation to prevent erosion and possible damage to the foundation.
Recommendation: Extend downspouts to direct water away from the foundation.

G 5.1 – Downspouts need extension.

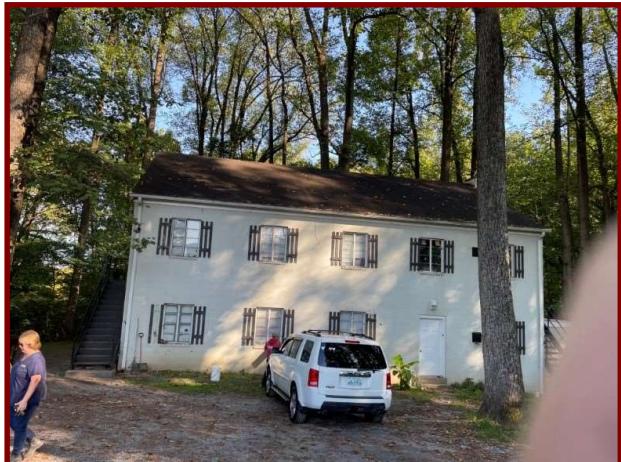
G 5.2 – Discoloring near grade.

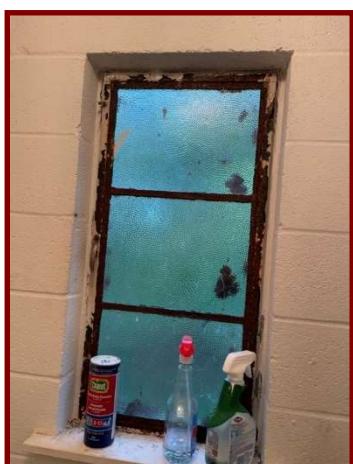
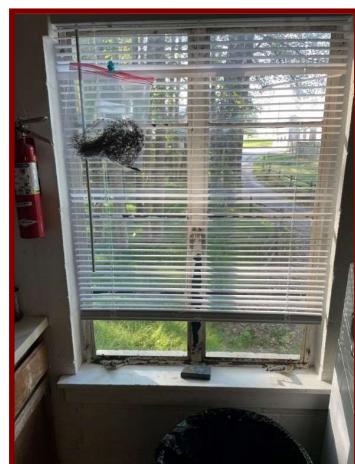
G 5.3c – Rusted Window Frames

G 5.3d – Rusted Window frames

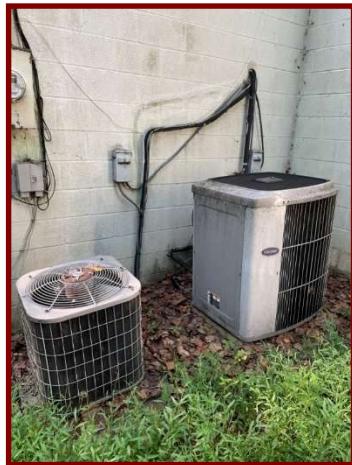
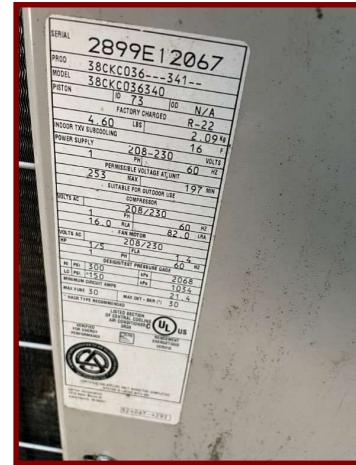
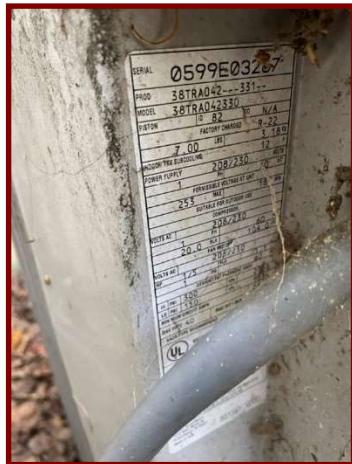
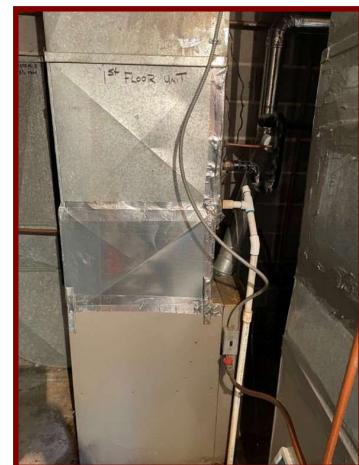
G 5.8 **Observation:** Separate systems condition the first and second floor spaces. Carrier condensing units were observed at the exterior of the mechanical space. One condenser was indicated to have been manufactured in July 1999 and the other February 1999. Both units are beyond their normal useful life of 15-20 years.
Recommendation: Replace the air conditioning systems.

G 5.8a – Exterior condensing units.

G 5.8b – Condensing unit tag.

G 5.8c – Condensing unit tag.

G 5.8d – AHU

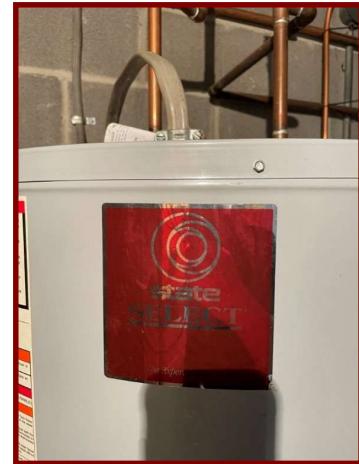
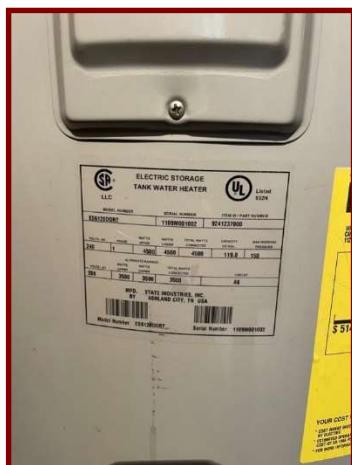
G 5.9 **Observation:** A State 119-gallon water heater was observed to have been manufactured in March of 2011. The unit is nearing the end of its normal useful life of 8-12 years.
Recommendation: Replace the water heater since it most likely receives a lot of use due to the building occupancy type and a malfunction would inconvenience many tenants.

G 5.9a – Water heater

G 5.9b – Water heater tag

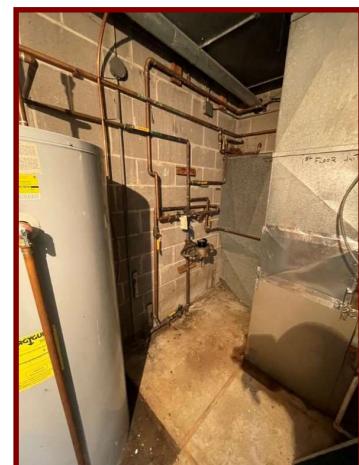
G – water heater and water meter

G5.8	Air conditioning system		1	LS									\$ 5,027.21
	Replace the air conditioning systems.		1	LS	\$ 2,350.00	\$ 2,350.00	\$ 870.00	\$ 870.00		\$ -	\$ 3,220.00	\$ 3,220.00	
G5.9	Water Heater		1	LS									\$ 4,006.15
	Replace the water heater since it most likely receives a lot of use due to the building occupancy type and a malfunction would inconvenience many tenants.		1	LS	\$ 2,325.00	\$ 2,325.00	\$ 241.00	\$ 241.00		\$ -	\$ 2,566.00	\$ 2,566.00	
	Subtotal - Direct Cost				\$ 61,448.56		\$ 21,993.32		\$ 145.25		\$ 83,587.13		
	Sales and Locality Tax		6	%		\$ 3,686.91			\$ 8.72		\$ 3,695.63		
	Subtotal										\$ 87,282.76		
	General Conditions		15	%							\$ 13,092.41		
	Subtotal										\$ 100,375.18		
	Contingency		30	%							\$ 30,112.55		
	Subtotal										\$ 130,487.73		
	Estimated Total Cost of Construction (Rounded to Nearest Hundred)										\$ 130,500.00	\$ 159,628.07

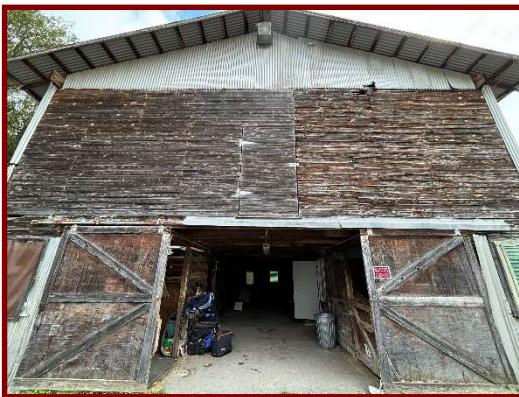
L 6.1 – Access to Second Level

Recommendation: Provide ladder access from second level (NFPA 101, 7.2.9).

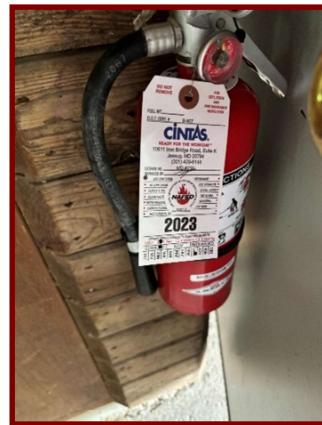
L 6.2 – Fire Extinguisher Hidden

Recommendation: Provide sign indicating the location of the fire extinguisher (NFPA 10, 6.1.3.3).

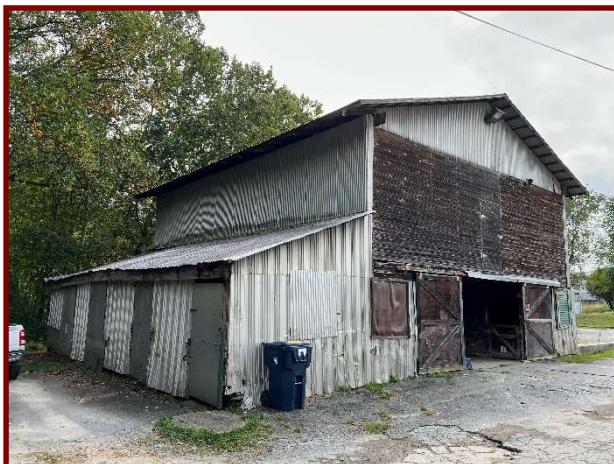
S 6.1a – Exterior view of Rear Barn, taken facing southeast.

S 6.1 **Observation:** At some locations in the structure we observed large and small holes in the corrugated metal siding, likely caused by weathering and corrosion. At other locations on the exterior we observed rusted panels. Openings in wall sheathing can lead to water infiltration and are often focal points for further deterioration. Current locations where rust is present will likely degrade further over time. At many locations metal siding has shifted and, in some cases, buckled. Shifted and buckled metal siding is indicative of building settlement and/or severe section loss of perimeter wood posts, as are some of our other observations.

Recommendation: At areas with limited to no section loss, clean the sheathing down to bare metal and apply a rust-inhibitive coating compatible with the base metal. Where sheathing has completely weathered away, replace the sheathing in-kind. Where sheathing has noticeably shifted and buckled, replace sheathing in-kind.

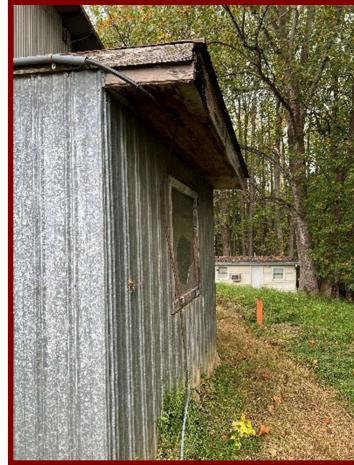
S 6.2 **Observation:** Many wooden members near and above grade are heavily degraded or show signs of degradation. Near grade, some members are heavily damaged by termites. Wood siding at the wash area has also deteriorated over time due to exposure to the elements, exposure to water during washing, and typical wear and tear.

S 6.2b – View of eave, window, and siding on east side of building.

Recommendation: Where possible, replace heavily damaged wood members or sister them with new pressure-treated lumber. Paint or otherwise moisture-protect exposed undamaged or lightly damaged exterior wood members. Replace and protect heavily deteriorated wood siding and ensure new siding is treated for water and moisture exposure. We also recommend conducting a test pit at 2 exterior wood columns to expose the below grade condition and determine how deep into the soil these columns are set. We recommend conducting a full building lateral analysis after completing the test pits to evaluate the lateral capacity of the structure.

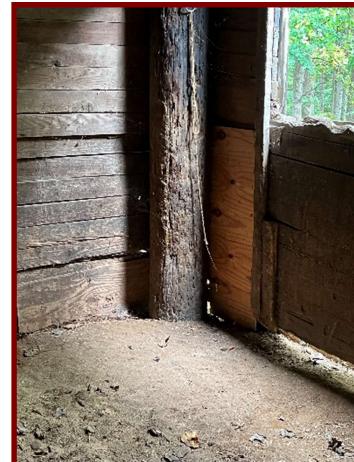
S 6.3 **Observation:** Several of the large posts are decayed at their bases. These posts do not appear to be pressure-treated or otherwise waterproofed. It is unclear if wood posts are in good condition below grade.

S 6.3 – Condition of structural post at interior. The below-grade condition of these posts is unclear.

Recommendation: Evaluate all wood posts for signs of decay above and below grade. Replace all decayed posts with new, pressure-treated posts to protect against future rot. Provide adequate concrete foundation support for new posts. This will require temporary shoring of the barn structure, excavation for new footings and piers, and installation of new footings and piers.

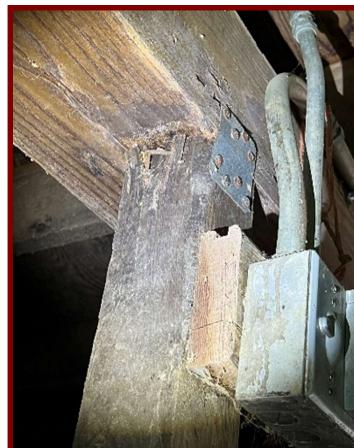
S 6.5 Observation: We noted crushing failure at the tops of several interior timber posts, associated with bearing of the timber beam framing supporting the second floor structure above. This may be indicative of either overloading of the timber posts due to storage loads placed on the second floor above, or past moisture damage and decay of the column top.

S 6.5 – Crushed top of post.

Recommendation: Performing repairs to interior posts noted earlier in this section will help to mitigate further settlement of the structure. Evaluate existing framing to determine if additional posts are required to reinforce the crushed posts.

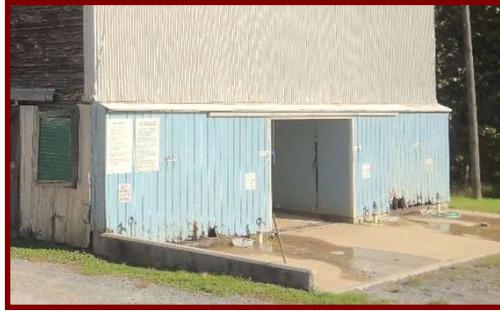
G 6.1 **Observation:** The wood siding at the wash area has deteriorated significantly at the base.
Recommendation: Replace wood siding at wash area.

G 6.1 – Wood siding deteriorating.

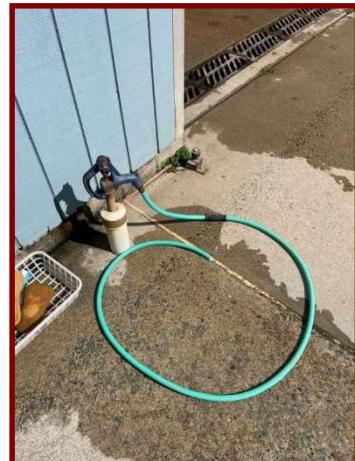
G 6.2 **Observation:** A outdoor spigot at the wash area was observed to be leaking and reported to need repair.
Recommendation: Replace the leaking outdoor spigot.

G 6.2 – Spigot leak.

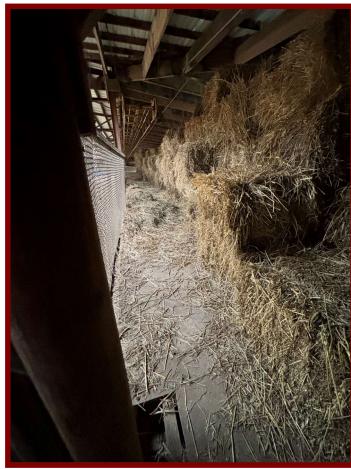
L 7.1 – Inadequate Clear Width in Egress Path

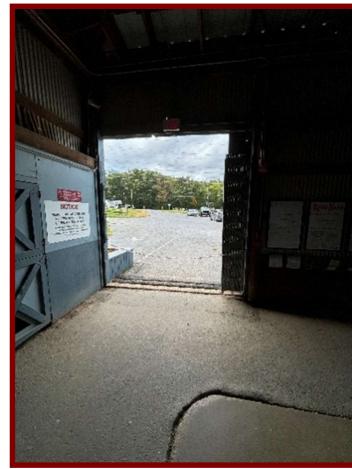
L 7.2 – Exit Door with Chain

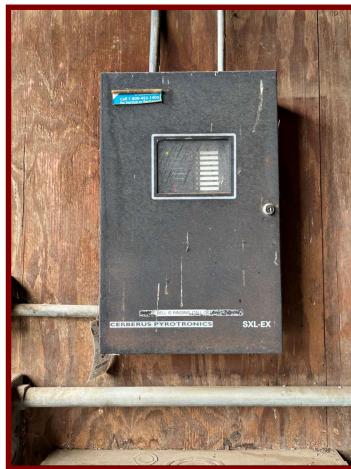
L 7.3 – Fire Alarm Control Unit (FACU)

Recommendations: A fire alarm system is not required by code; however, the following are recommended for the existing fire alarm system:

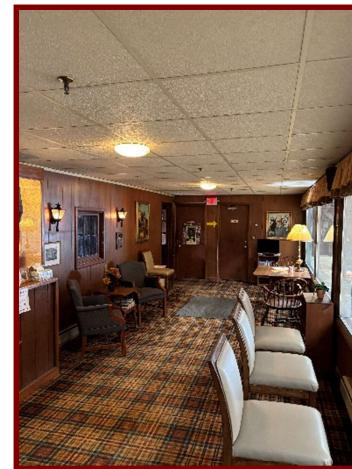
L 7.4 – Sprinklers on Ceiling In Office

Recommendation: A fire sprinkler system is not required by code, however the following are recommendations for the fire sprinkler system:

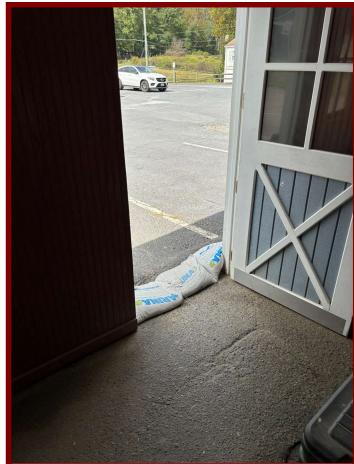
L 7.5 – Egress Door with Tripping Hazard

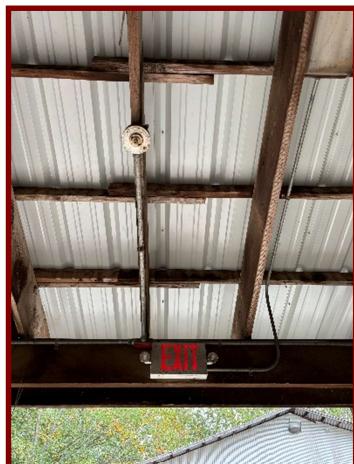
L 7.6b – Heat Detector Rust/Corrosion

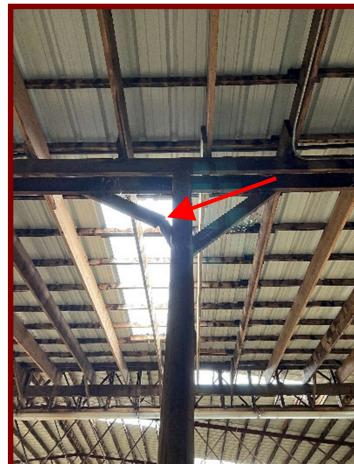
S 7.4a – Broken brace on east side of riding area.

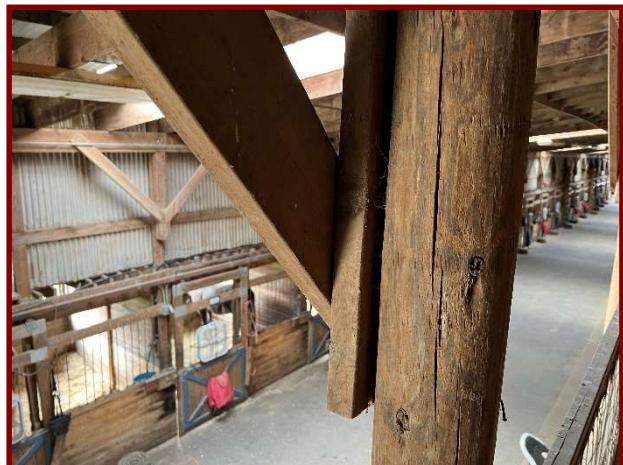
S 7.4c – Laterally shifted vertical member. These members connect the braces to the post.

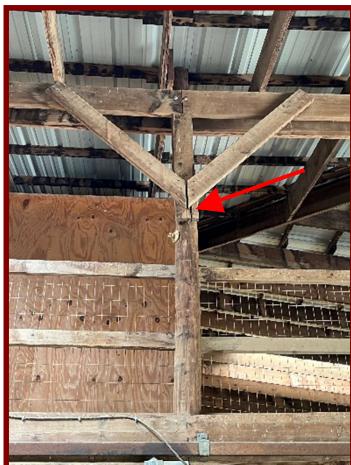
S 7.4d – Separated braces and broken vertical brace member. The break pattern suggests these members carry lateral loads.

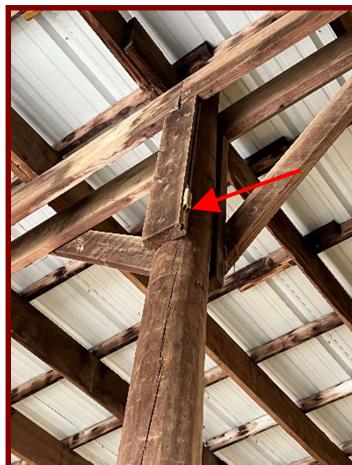
S 7.4e – Termite damage in brace at west side of riding area.

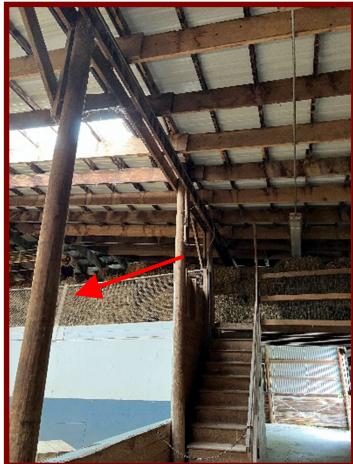
S 7.5 – View of hay loft at northeast side of riding area. Note poor condition of metal railing and associated members.

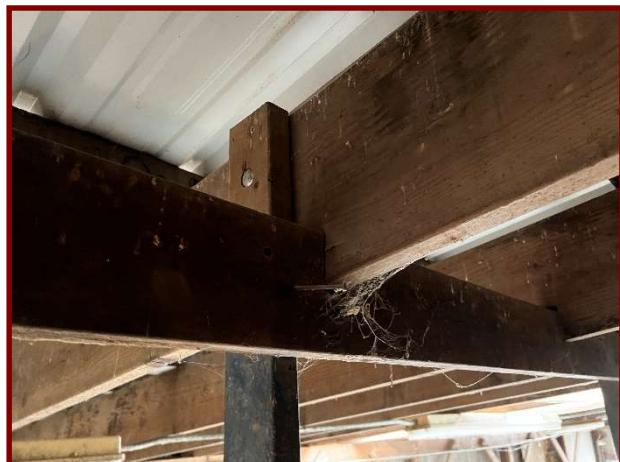
S 7.6 **Observation:** Sloped rafters above the stable area are notched at bases to accommodate other wood framing members. Notching the members has significantly reduced the section of the member and reduced the capacity of the system. We observed a cracked notched member at one location.

S 7.6b – Close view of notched beam.

Recommendation: Engage an engineer to analyze the structure and determine the demand on and capacity of the notched rafters. Sister notched rafters as required.

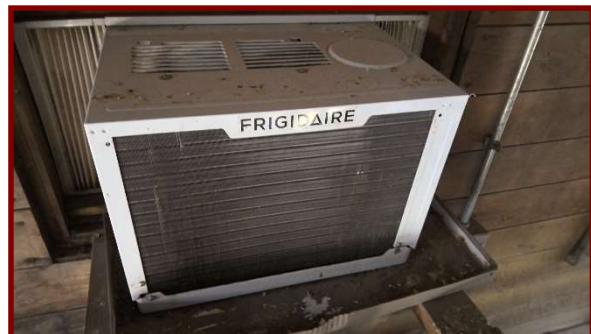
G 7.4 – Window units at office mezzanine.

Provide an ADA compliant drinking fountain.	1	EA	\$ 965.00	\$ 965.00	\$ 144.00	\$ 144.00	\$ -	\$ -	\$ 1,109.00	\$ 1,109.00			
G7.3	Water Heater	1	EA											\$ 2,660.93
	Replace the water heater.	1	EA	\$ 1,325.00	\$ 1,325.00	\$ 385.00	\$ 385.00	\$ -	\$ -	\$ 1,710.00	\$ 1,710.00			
G7.4	Air conditioning units	3	EA											\$ 2,885.01
	Investigate the age of the air conditioning units and replace as necessary.	3	EA	\$ 540.00	\$ 1,620.00	\$ 78.00	\$ 234.00	\$ -	\$ -	\$ 618.00	\$ 1,854.00			
	Subtotal - Direct Cost					\$ 315,531.88		\$ 155,264.35		\$ 12,720.00		\$ 483,516.23		
	Sales and Locality Tax	6	%			\$ 18,931.91				\$ 763.20		\$ 19,695.11		
	Subtotal											\$ 503,211.34		
	General Conditions	15	%									\$ 75,481.70		
	Subtotal											\$ 578,693.04		
	Contingency	30	%									\$ 173,607.91		
	Subtotal											\$ 752,300.95		
	Estimated Total Cost of Construction (Rounded to Nearest Hundred)											\$ 752,400.00	\$ 964,654.68

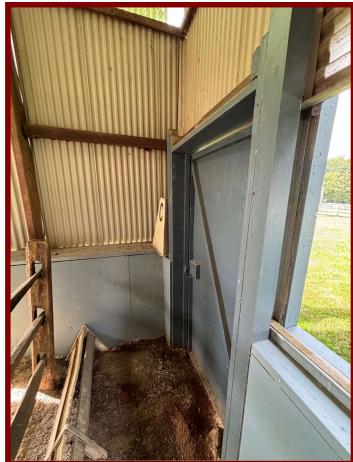
L 8.1 **Observation:** The Large Arena has three exit doors, but two of them are permanently closed or blocked and unable to be opened. NFPA 101 requires that two exits be provided for assembly occupancies with less than 600 occupants (NFPA 101, 13.2.4).
Recommendations: Allow for both currently locked egress doors to be opened in order to provide a second remote means of egress.

L 8.1a – Permanently Closed Egress Door

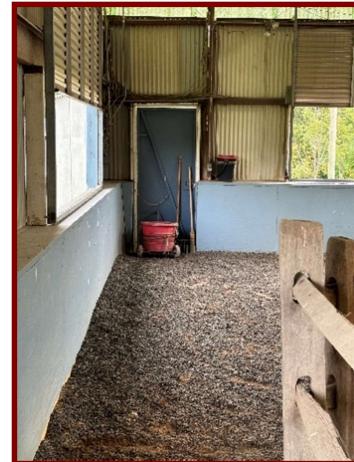
L 8.1b – Blocked and Unusable Egress Door

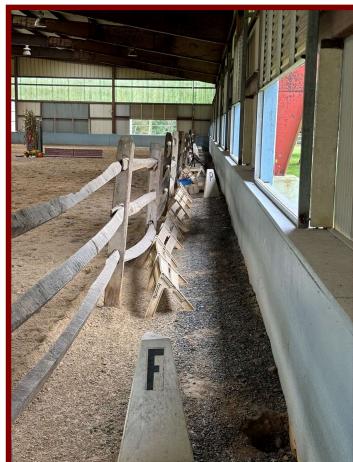
L 8.2 **Observation:** Egress paths for the Large Arena are not well maintained. The path to the exit door (that does not open currently) in the back corner of the building is blocked by miscellaneous items constantly throughout the path. Additionally, the egress path is very uneven and narrow.
Recommendations: Provide egress path that is minimum 28 inches in width (NFPA 101, 7.3.4.1.2), clear from obstructions and tripping hazards (NFPA 101, 7.1.10.1), and with a level surface (NFPA 101, 7.1.6).

L 8.2 – Uneven Walking Surface

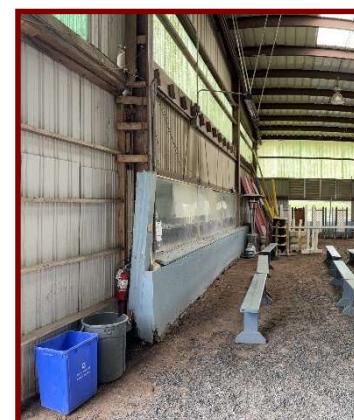
L 8.3 **Observation:** Fire extinguisher is located behind a column that obstructs visibility of the extinguisher. Fire extinguisher is not marked with a sign to point out its location.
Recommendations: Provide sign indicating the location of the fire extinguisher (NFPA 10, 6.1.3.3).

L 8.3 – Blocked Fire Extinguisher

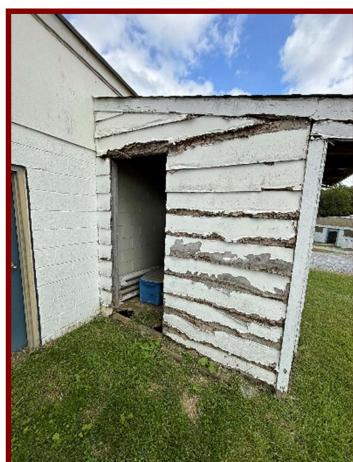
L 8.4 **Observation:** Storage shed attached to building is deteriorating, including the floorboards immediately touching the exit.
Recommendations: Replace and repair floors and siding of the shed or demolish the shed.

L 8.4 – Deteriorating Floor Boards

L8.4	Storage shed attached to building is deteriorating, including the floorboards immediately touching the exit.	1	LS									\$ 2,687.97
	Replace and repair floors and siding of the shed or demolish the shed.	1	LS	\$ 568.00	\$ 568.00	\$ 1,150.00	\$ 1,150.00	\$ -	\$ -	\$ 1,718.00	\$ 1,718.00	
S8.1	Exterior metal panels	1	LS									\$ 171,756.03
	At areas with limited to no section loss, clean the sheathing down to bare metal and apply a rust-inhibitive coating compatible with the base metal.	1	LS	\$ 12,240.00	\$ 12,240.00	\$ 6,825.00	\$ 6,825.00	\$ -	\$ -	\$ 19,065.00	\$ 19,065.00	
	If sheathing has completely weathered away, replace the sheathing in-kind.	1	LS	\$ 74,800.00	\$ 74,800.00	\$ 15,912.00	\$ 15,912.00	\$ -	\$ -	\$ 90,712.00	\$ 90,712.00	
S8.2	Interior Metal Panels		LS									\$ 171,756.03
	Grind rusted steel until bare metal is exposed and apply a rust-inhibitive coating.	1	LS	\$ 12,240.00	\$ 12,240.00	\$ 6,825.00	\$ 6,825.00	\$ -	\$ -	\$ 19,065.00	\$ 19,065.00

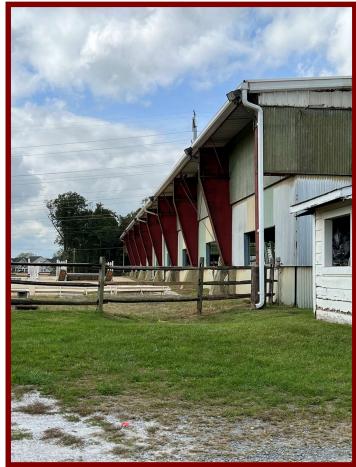
S 8.1 **Observation:** We observed rusted panels at the building exterior. Openings in wall sheathing can lead to water infiltration and are often focal points for further deterioration. Current locations where rust is present will likely degrade further as time passes.
Recommendation: At areas with limited to no section loss, clean the sheathing down to bare metal and apply a rust-inhibitive coating compatible with the base metal. If sheathing has completely weathered away, replace the sheathing in-kind.

S 8.1a – Exterior view of Large Indoor Riding Arena, taken facing west.

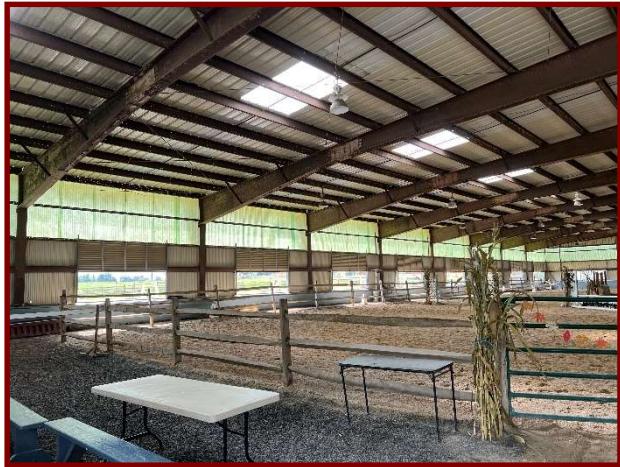
S 8.1b – Interior view of Large Indoor Riding Arena, same side as preceding photo.
