**Potomac Horse Center
North Potomac, Maryland
Facility Condition Assessment Report**

November 22, 2023

Reference: **Potomac Horse Center**
Facilities Condition Assessment – Final Report
North Potomac, Maryland

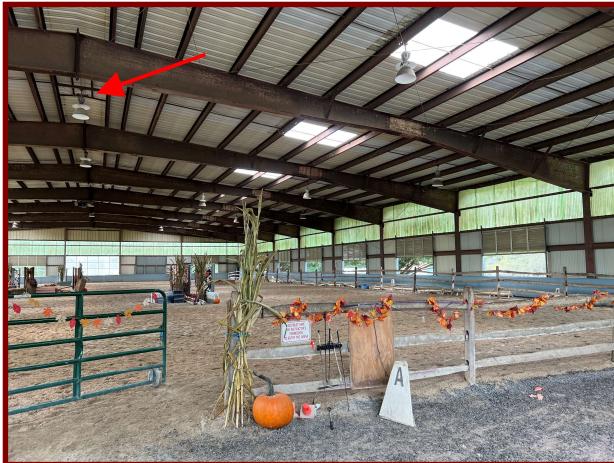
S 8.2 **Observation:** We observed minor surface rust at many locations, likely due to the structure's general exposure to atmospheric moisture and expected decay of surface primer over its service life. Small sections, such as the roof purlins, are especially susceptible to rust.
Recommendation: Grind rusted steel until bare metal is exposed and apply a rust-inhibitive coating. If during this process members are discovered to be significantly corroded, take corrective action such as repairing, reinforcing, or replacing the member in question.

S 8.2 – Interior view of Large Indoor Riding Arena. Note small purlins where indicated.

If during this process members are discovered to be significantly corroded, take corrective action such as repairing, reinforcing, or replacing the member in question.	1	LS	\$ 74,800.00	\$ 74,800.00	\$ 15,912.00	\$ 15,912.00	\$ -	\$ -	\$ 90,712.00	\$ 90,712.00	
S8.3	Roof joists	1	LS									\$ 18,775.08
	Engage an engineer to analyze the area tributary to where the roof joists from the side building bear.	1	LS	\$ -	\$ 2,000.00	\$ 2,000.00	\$ -	\$ -	\$ 2,000.00	\$ 2,000.00		
	Reinforce or retrofit the structure as necessary. This will likely consist of installing new steel beams to reinforce the existing wind girts, installing new cross bracing to increase lateral capacity of building to brace the east addition, and local column reinforcing to increase vertical capacity.	1	Allow	\$ -	\$ -	\$ -	\$ -	\$ 10,000.00	\$ 10,000.00	\$ 10,000.00	\$ 10,000.00	
S8.4	CMU walls	1	LS									Pricing by others

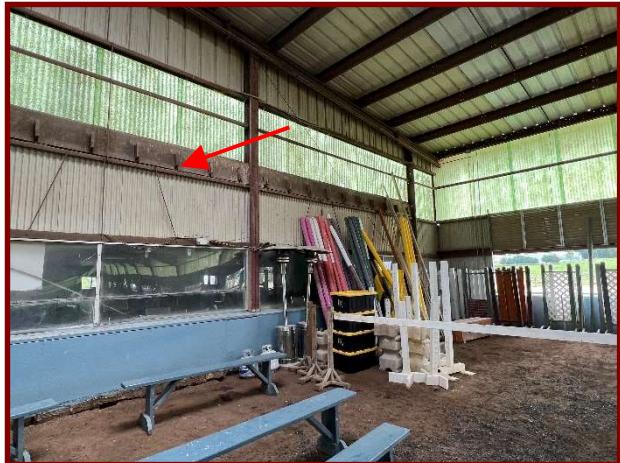
S 8.3 **Observation:** Where the east addition meets the east end of the building, roof joists from the side addition were constructed to bear on the wind girts of the main building, with no observed supplemental reinforcement of the wind girts. It is unlikely the girts and the columns they connect to were designed to take the load from the east addition, and therefore may not have adequate reserve capacity to support the additional loads superimposed by the roof framing of the east addition.
Recommendation: Engage an engineer to analyze the area tributary to where the roof joists from the side building bear. Reinforce or retrofit the structure as necessary. This will likely consist of installing new steel beams to reinforce the existing wind girts, installing new cross bracing to increase lateral capacity of building to brace the east addition, and local column reinforcing to increase vertical capacity.

S 8.3 – East corner of Large Indoor Riding Arena. Note where roof joists from side building bear on wind girts.

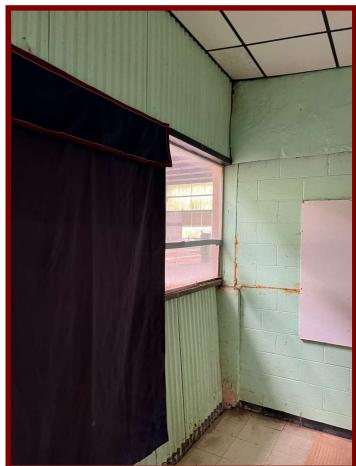
S 8.4 **Observation:** CMU walls in the east addition are cracked in multiple locations in both the interior and exterior. Cracking may be caused by building settlement or other subsurface action.
Recommendation: Investigate the foundations and subsurface conditions around the east addition. Provide adequate drainage in the area surrounding the addition to mitigate potential soil consolidation. Repair cracks in CMU walls to prevent further deterioration of these areas. Install crack monitors to determine if movement is continuing or has stopped.

S 8.4a – Interior of side building, facing northwest towards the Large Indoor Riding Arena.

Investigate the foundations and subsurface conditions around the east addition.	1	LS	\$ -	\$ -	\$ -	\$ -	\$ -	\$ -	\$ -	\$ -	
	Provide adequate drainage in the area surrounding the addition to mitigate potential soil consolidation.	1	LS	\$ -	\$ -	\$ -	\$ -	\$ -	\$ -	\$ -	\$ -	
	Repair cracks in CMU walls to prevent further deterioration of these areas.	1	LS	\$ -	\$ -	\$ -	\$ -	\$ -	\$ -	\$ -	\$ -	
	Install crack monitors to determine if movement is continuing or has stopped.	1	LS	\$ -	\$ -	\$ -	\$ -	\$ -	\$ -	\$ -	\$ -

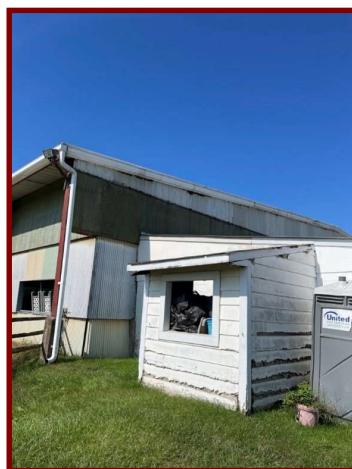
G 8.1 **Observation:** The exterior coating of siding of the building was deteriorated. Green translucent panels of the exterior façade allowed light into the building. The panels were observed to be dirty on the inside and outside.

G 8.1c – Deteriorating exterior façade.

Recommendation: Repaint exterior siding and clean the translucent panels on the inside and outside.

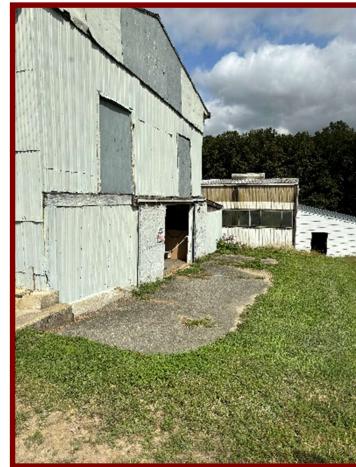
L 9.1 **Observation:** One exit has a chain across, which restricts egress. Egress should not be restricted while building is occupied.
Recommendations: Ensure that chain is only provided when building is unoccupied (NFPA 101, 7.2.1.5.1).

L 9.1 – Gray Barn Exit

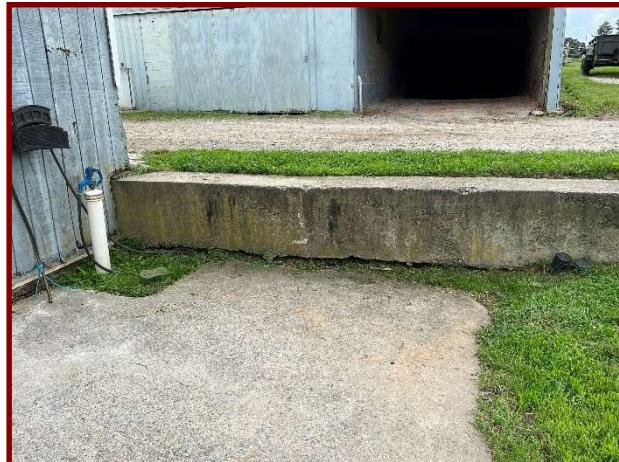
S 9.1 **Observation:** The concrete wall on the south side of the Gray Barn is deteriorated at its base, shows signs of lateral movement, and does not appear to have any footing. It is very likely that the wall does not satisfy code requirements for frost protection, overturning, or sliding. It is unclear whether or not this wall continues under the south side of the barn itself. If confirmed, the deterioration and lateral movement of the wall poses a risk to the building's structure.
Recommendation: Unless action is taken, we anticipate that the wall will continue to deteriorate and move laterally. We recommend replacing the knee wall with a new wall assembly governed by a new engineered design. We recommend removing interior wall finishes to expose the framing along the south exterior wall to allow for a structural engineer to evaluate the existing wood framing and foundation condition of the southern wall and verify if the existing exterior concrete wall pour continues into the footprint of the barn.

S 9.1 – Concrete wall with no footing. It is unclear if this wall continues under the south side of the barn.

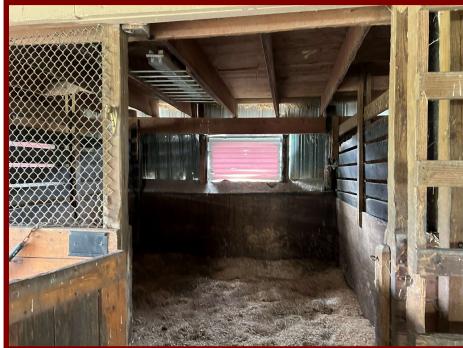
S 9.4 **Observation:** Many joists and headers at the lower level have been sistered with new lumber, and many posts have either been added or cut over the building's service life. It is clear from these observations that the load path has changed significantly over time and is at this point effectively indeterminate.
Recommendation: Inspect and analyze the building further to determine the load path. Once this is done, modify and reinforce the structure as necessary to ensure the facility is up to current code standards.

S 9.4a – Typical framing condition at lower level stalls.

S9.4	Structure Reinforcing	1	LS										\$ 13,872.08
	Inspect and analyze the building further to determine the load path.	1	LS	\$ -	\$ -	\$ 4,000.00	\$ 4,000.00	\$ -	\$ -	\$ 4,000.00	\$ 4,000.00		
	Once this is done, modify and reinforce the structure as necessary to ensure the facility is up to current code standards.	1	Allow	\$ -	\$ -	\$ 5,000.00	\$ 5,000.00	\$ -	\$ -	\$ 5,000.00	\$ 5,000.00		
G1.1	Damaged exterior elements	1	LS										\$ 86,662.91
	Replace damaged siding, trim, and doors.	1	LS	\$ 44,740.00	\$ 44,740.00	\$ 11,485.60	\$ 11,485.60	\$ -	\$ -	\$ 56,225.60	\$ 56,225.60		
	Subtotal - Direct Cost				\$ 57,921.29		\$ 56,268.89		\$ 1,098.92		\$ 115,289.10		
	Sales and Locality Tax	6	%		\$ 3,475.28				\$ 65.94		\$ 3,541.21		
	Subtotal										\$ 118,830.31		
	General Conditions	15	%								\$ 17,824.55		
	Subtotal										\$ 136,654.86		
	Contingency	30	%								\$ 40,996.46		
	Subtotal										\$ 177,651.31

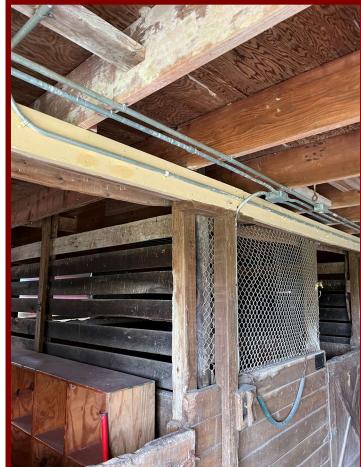
S 9.4c – Multiple beams that appear to have been constructed at different times bear at the same location.

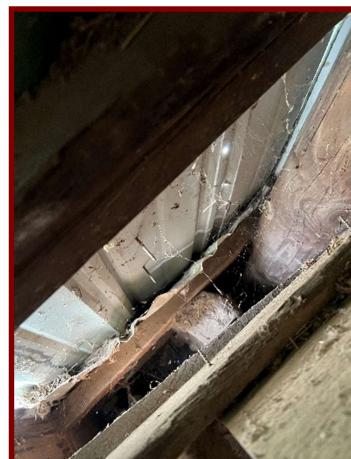
S 9.4d – Cut wooden post near other framing, including another wooden post.

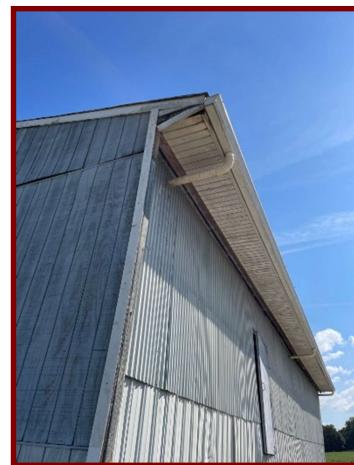
G 1.1 **Observation:** Numerous siding panels, wood trim, and wooden egress door and stall windows were observed to be damaged or deteriorated.

G 9.1b – Soffit.

Recommendation: Replace damaged siding, trim, and doors.

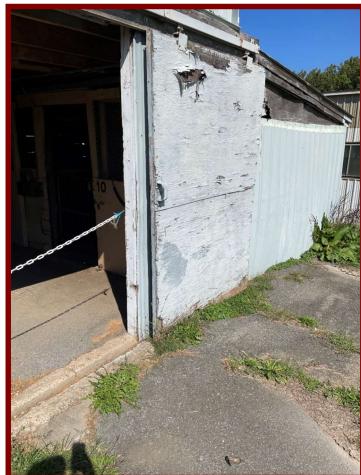
G 9.1c – Door

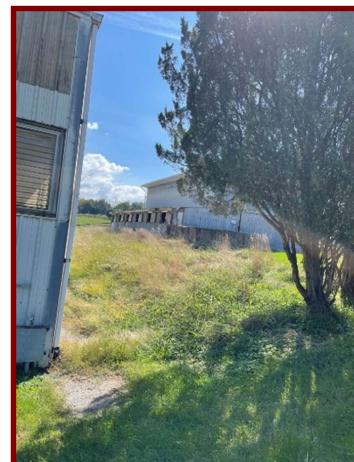
G 9.1d – extend down spout or provide splash guard.

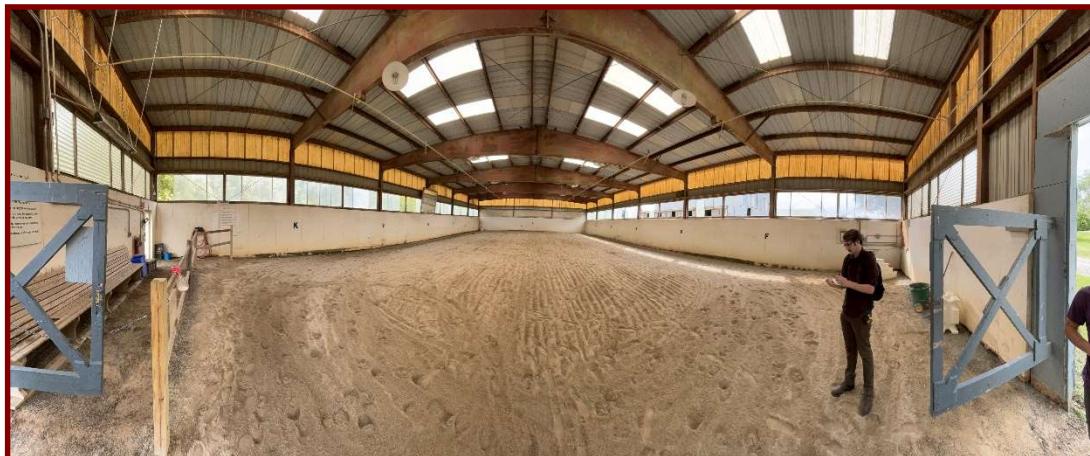
L 10.1 – Small Arena

Recommendations: Provide a second remote means of egress, located in the opposite corner of the building.

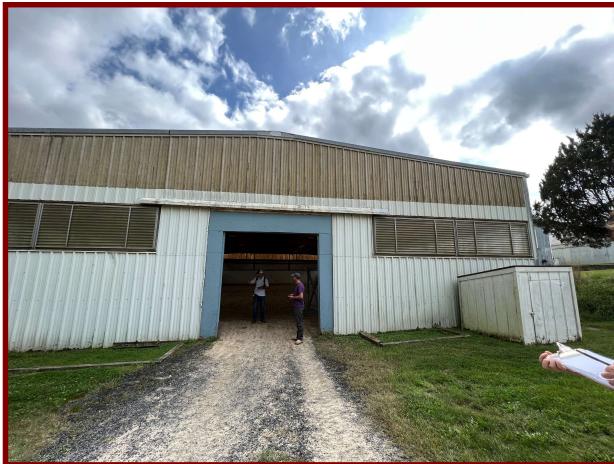
S 10.1 Observation: Rusted panels at the building exterior. Openings in wall sheathing can lead to water infiltration and are often focal points for further deterioration. Current locations where rust is present will likely degrade further as time passes.

S 10.1 – Exterior view of Small Arena, facing southeast.

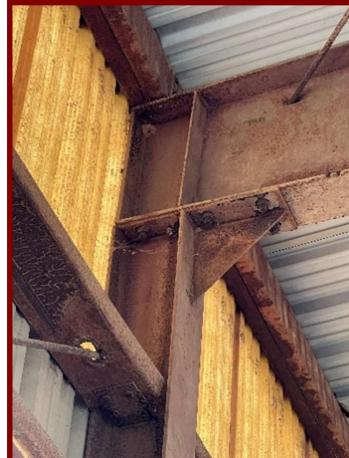
S 10.4b – Deflected beam end and column top at column "K".

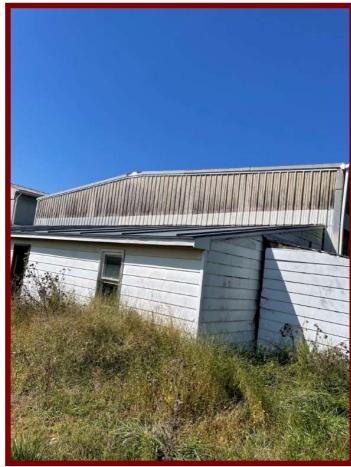
G 10.1a – Exterior finish deteriorating.

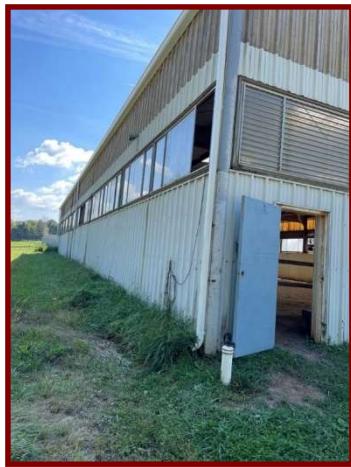
G 10.2 Observation: Several panels of the windows of the north and south elevations were missing.

G 10.2 – Missing windows

Recommendation: Replace missing window panels.

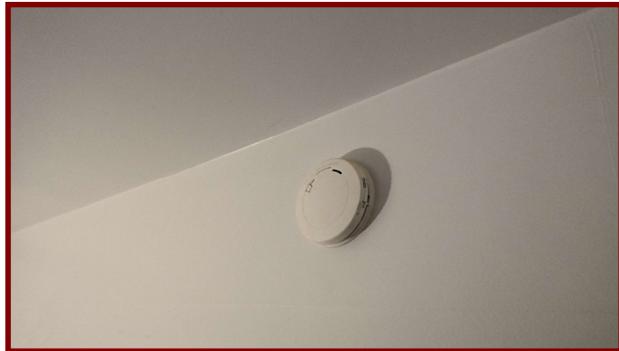
G 11.1a – Bedroom Smoke Alarm

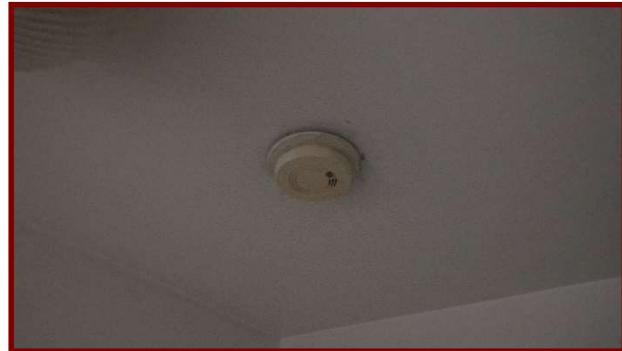
G 11.1b – Hall Smoke Alarm

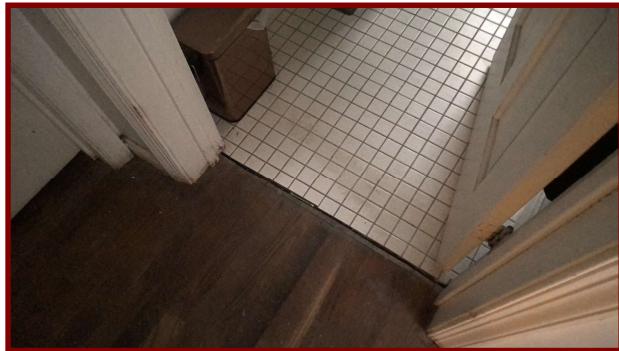
G 11.2 – Flooring Transition

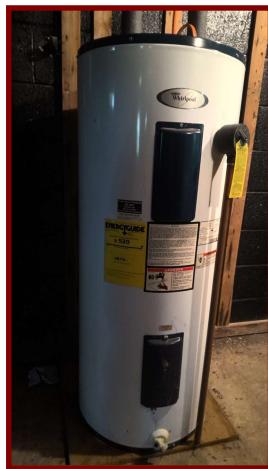
G 11.4a – Water Heater

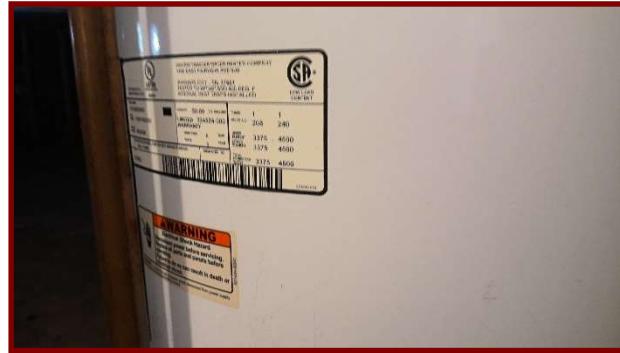
G 11.4b – Water Heater

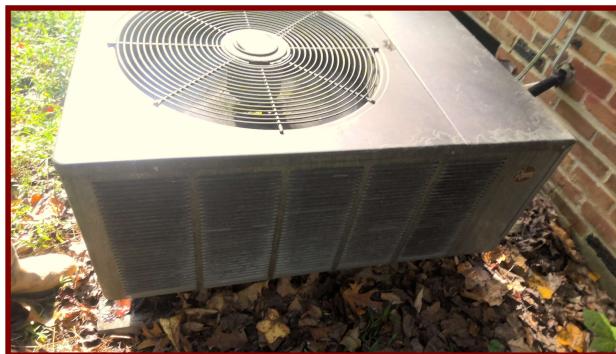
G 11.5a – Exterior Condensing Unit

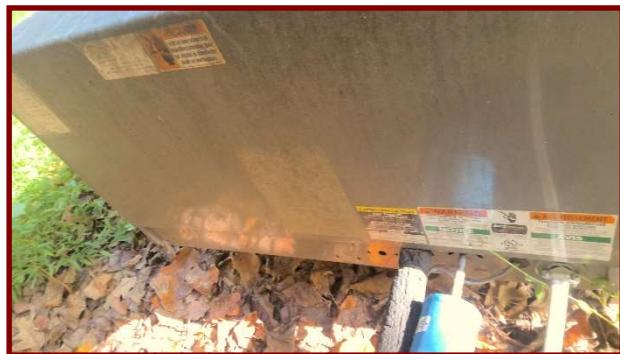
G 11.5b – Exterior Condensing Unit

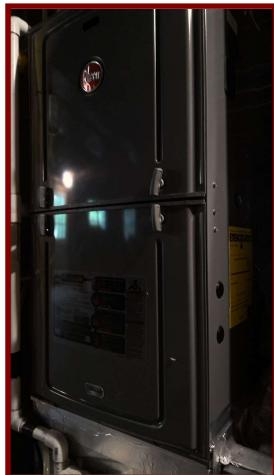
G 11.5c – Interior Unit

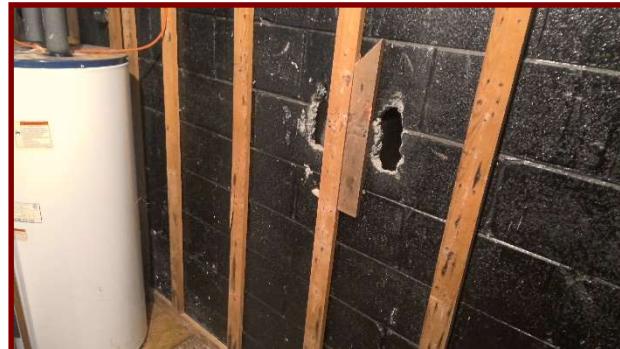
G 11.6a – Holes in CMU

G 11.6 **Observation:** There are several unsealed penetrations through the walls in the basement.
Recommendation: Properly seal all penetrations and repair the holes in the CMU wall.

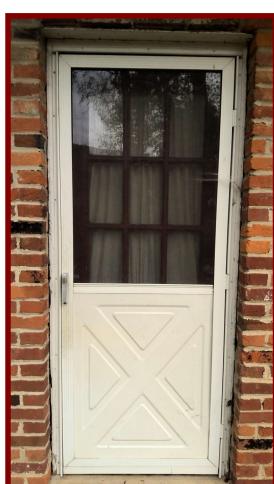
G 11.7 – Door trim and sealant

G 11.7 **Observation:** Exterior doors are not sealed and trim shows signs of decay.
Recommendation: Properly seal around doors after repairing or replacing the door trim.
