**Maryland Department of the Environment (MDE)
Water Management Administration (WMA)
FY 2017 ANNUAL REPORT
National Pollutant Discharge Elimination System (NPDES)
General Permit for Discharges from Small Municipal Separate Storm Sewer Systems**

**Maryland-National Capital Park and Planning Commission,
Department of Parks, Montgomery County**

This report covers Fiscal Year 2017 (FY17), which ran from 7/1/2016 to 6/30/2017.

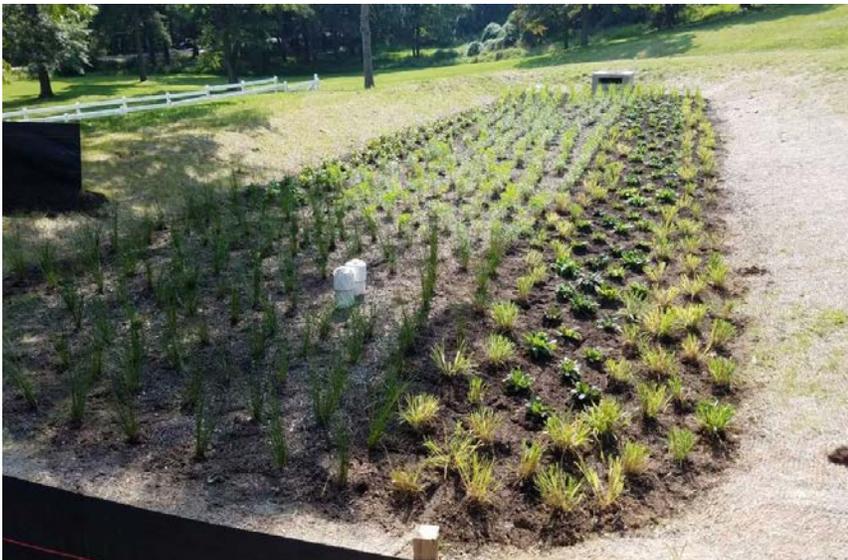
Above: Plants play a large role in the function of a bioretention facility, absorbing rain water and filtering out large particles and contaminants. Plants installed in a bioretention facility recently constructed at the Wheaton Stables site include Grass-leaved Goldenrod, Beaked Panicgrass, Swamp Aster, Brown-eyed Susan, Juncus, and Woolgrass.

Bioretention facilities continue to be the most maintenance-heavy stormwater management facilities installed on Parkland. There are currently 82 bioretention facilities on Montgomery County Parkland. Multiple new bioretention facilities are added each year as existing parks are retrofit to include SWM, new parks are constructed, new land is acquired, and other agencies build projects on existing Parkland. Bioretention facilities require year-round maintenance including weeding, pruning, mulching, and leaf removal. Weeding bioretention facilities is the most time-intensive, yet the most important maintenance task to keep facilities functioning properly. This labor-intensive maintenance is a large cost to Parks. However, a savings on plant material costs is realized by Parks' use of plants grown at in-house Pope Farm Nursery.

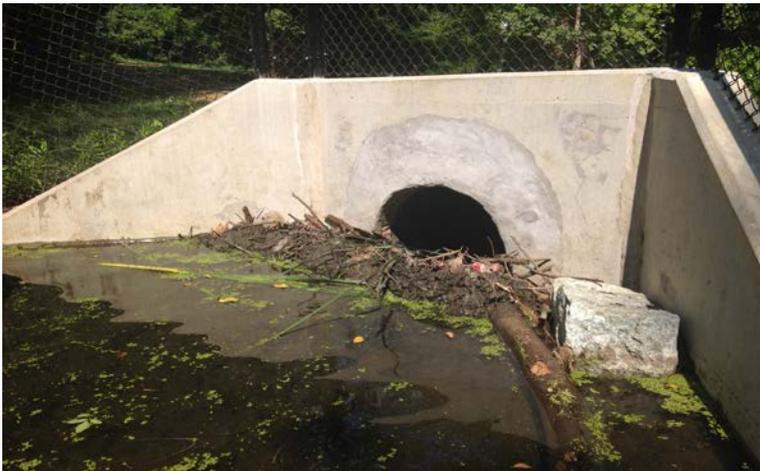
Above: Beaver activity impacted the function of this stormwater management facility. These types of issues are discovered and corrected throughout the year.

Wildlife management associated with SWM facilities continued FY17 with the oiling of approximately 778 Canada Goose eggs, the removal of five beavers and the removal of seven groundhogs. Beavers and groundhogs are only removed from stormwater management facilities if it is determined that their activities are impacting the structural components of the facility. Canada Goose egg oiling treatments provide relief from property damage, adverse water quality effects, and impacts to agriculture. It also decreases the risk of public safety issues.

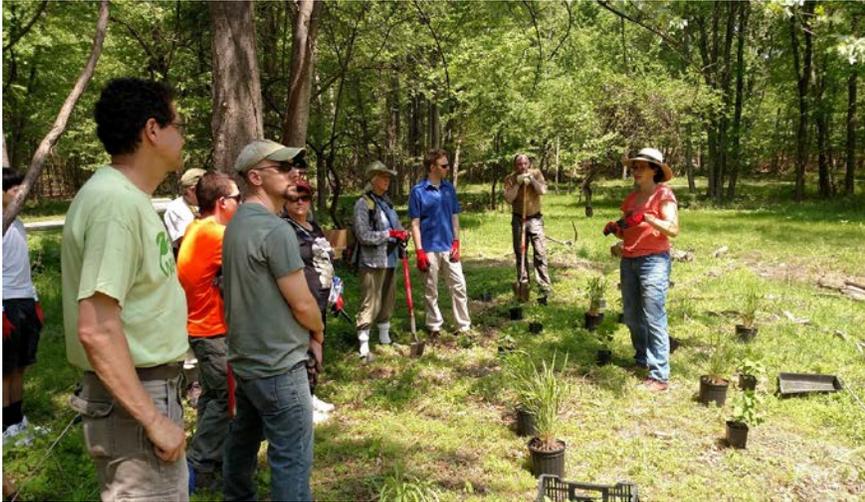
Above: Volunteers planted a new microtopography project in the floodplain of Sligo Creek.

In a new initiative in FY17, areas in 17 different locations along our stream valleys were graded to create microtopography in areas that received some level of impervious runoff. These locations were often inappropriate for traditional stormwater facilities but allow for settling and treatment of runoff prior to entering our streams. Sites were altered to provide varying depths (3-18") of water, planted with native wetland vegetation, and strewn with large woody debris for habitat. The ecological benefits of these areas, mostly previously mowed turf grass, in just one growing season have been notable, and we look forward to monitoring how they evolve in coming years.

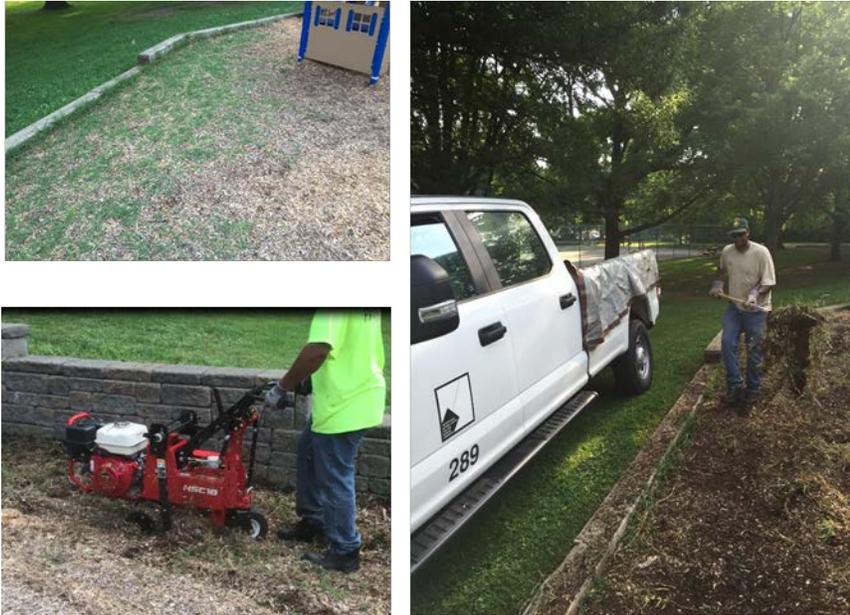
Above: Parks is using mechanical removal methods (sod cutter at bottom left) in place of pesticides where possible.

Beginning in July 2016, 284 playgrounds in parks became pesticide-free. Over 60% of these were previously managed with herbicides. Two crews were created to perform playground surfacing maintenance, which includes removal of weeds using hand and machine-operated tools. In addition, the innovative use of a sod-cutter helps

loosen weeds from the wood fiber/playground mulch, so they can be removed and taken to our Pope Farm compost facility.
